REPORT WRITTEN: February 1959

**NUCLEAR-CRITICAL ACCIDENT AT THE LOS ALAMOS
SCIENTIFIC LABORATORY ON DECEMBER 30, 1958**

H. C. Paxton
R. D. Baker
W. J. Maraman
Roy Reider

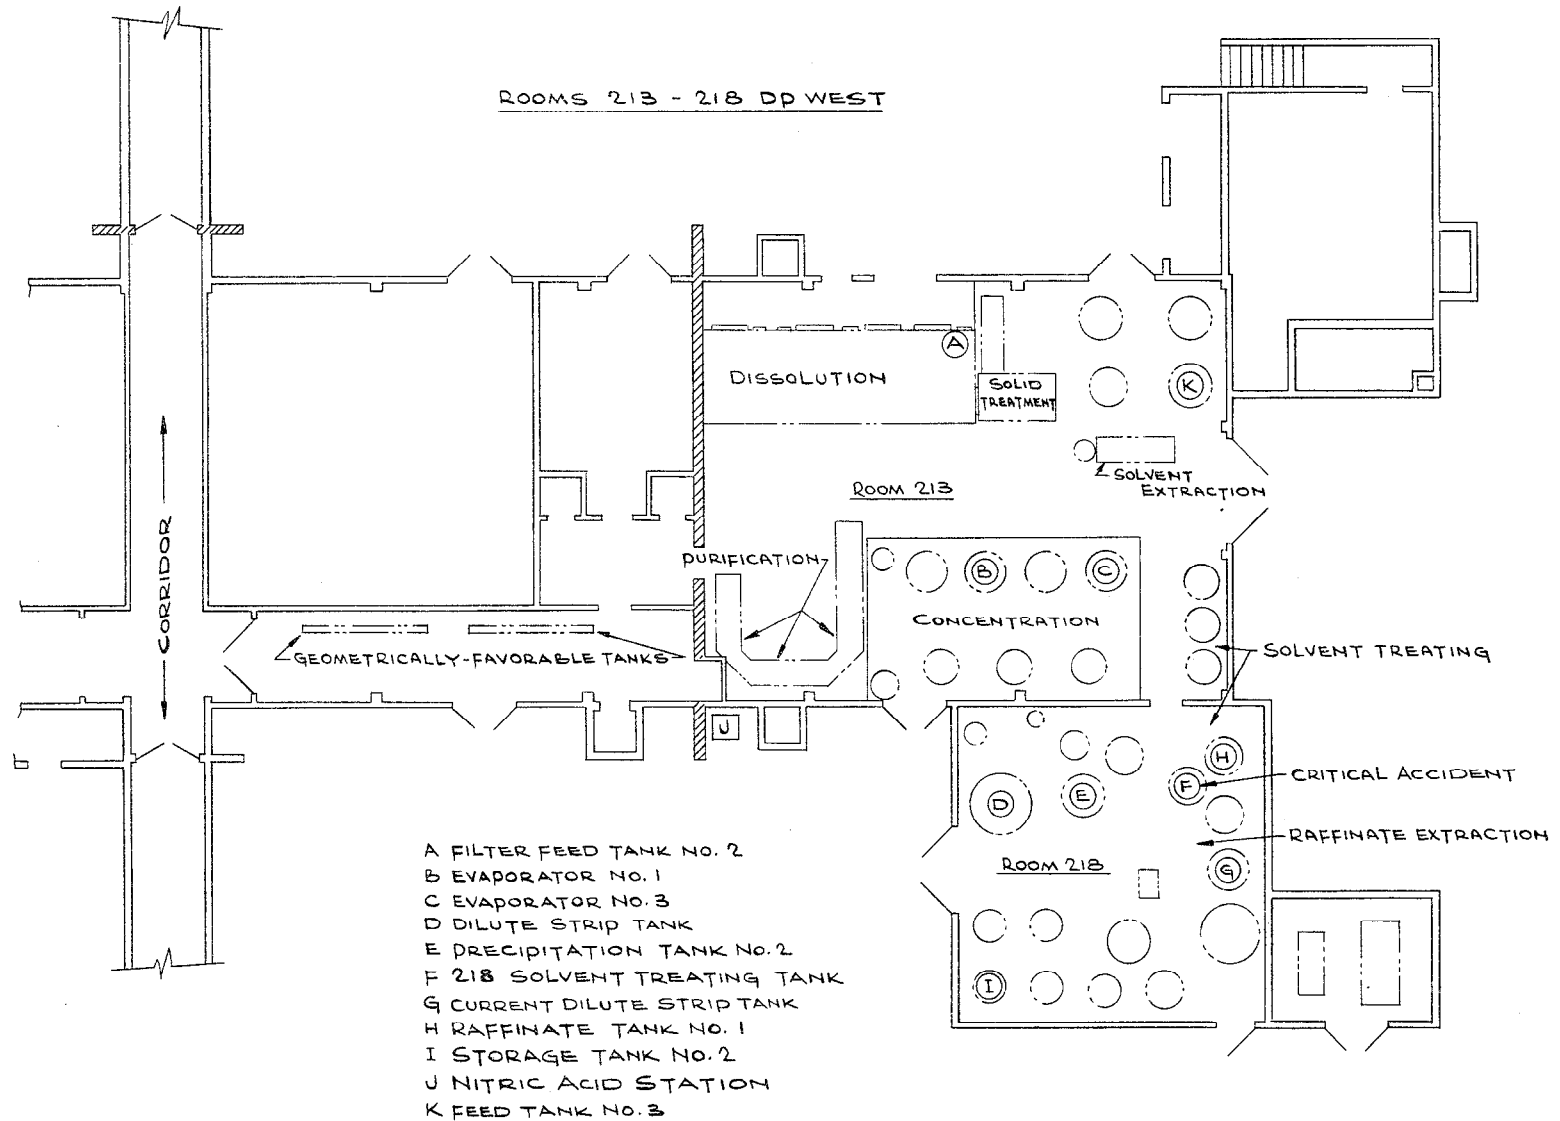
Fig. 3 Layout of equipment in area where accident occurred.

Material transfers leading up to the accident were as follows (refer to Fig. 3 for container locations).

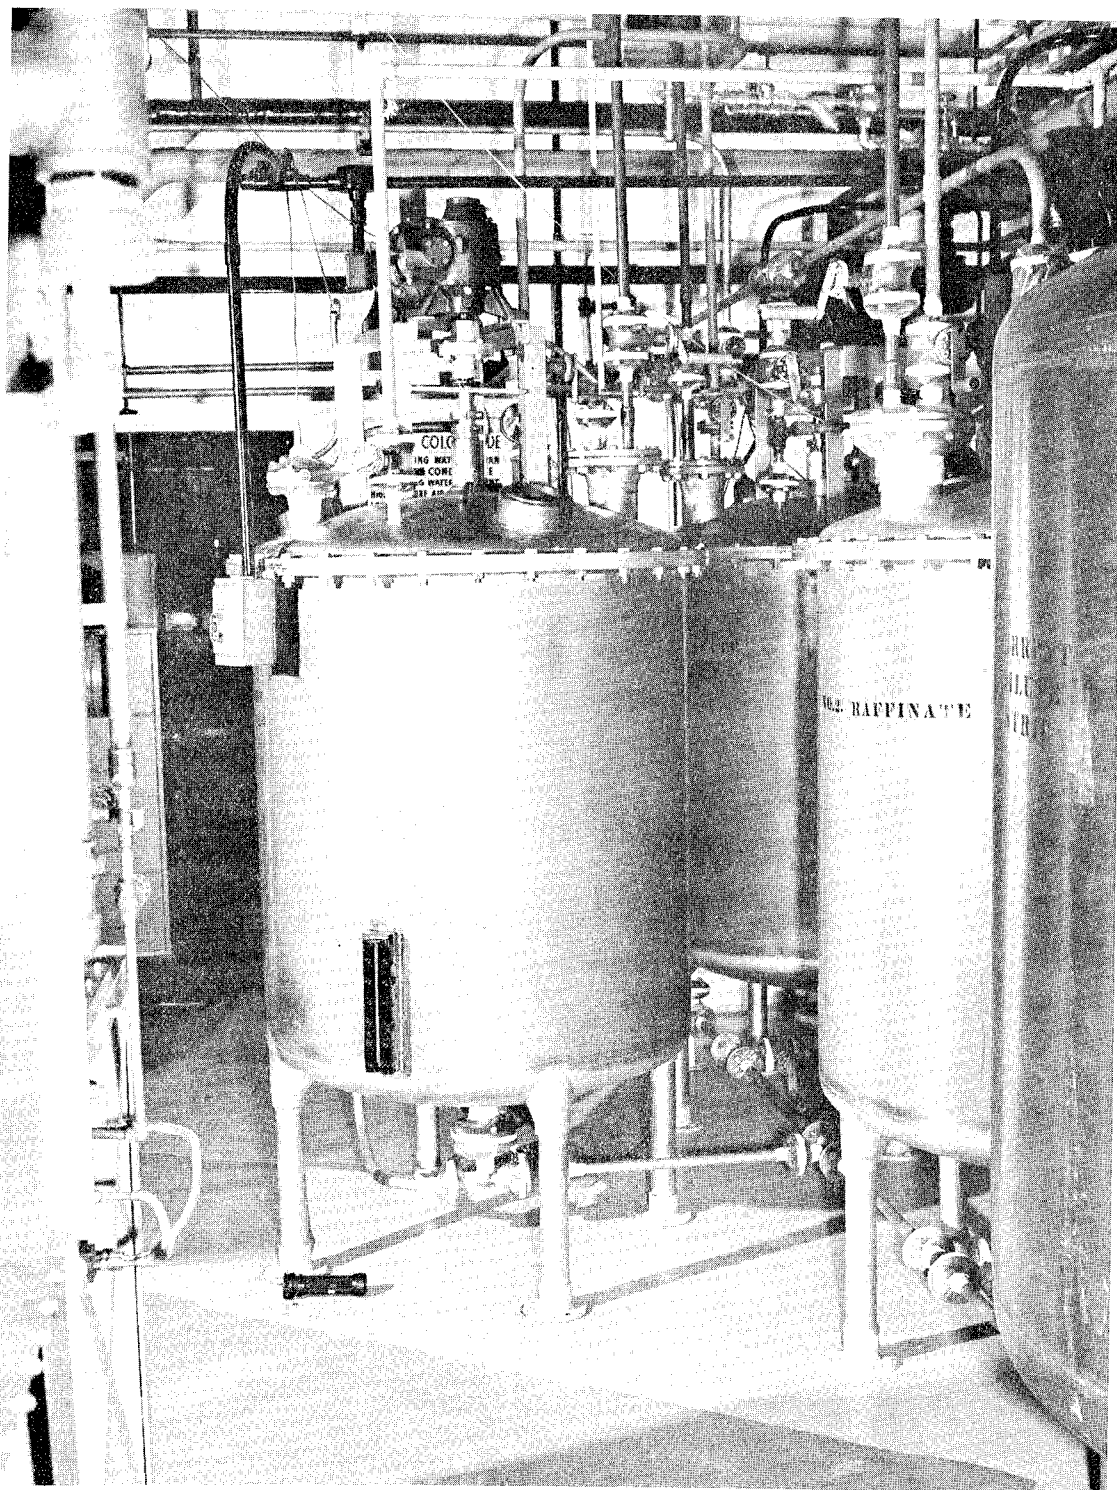
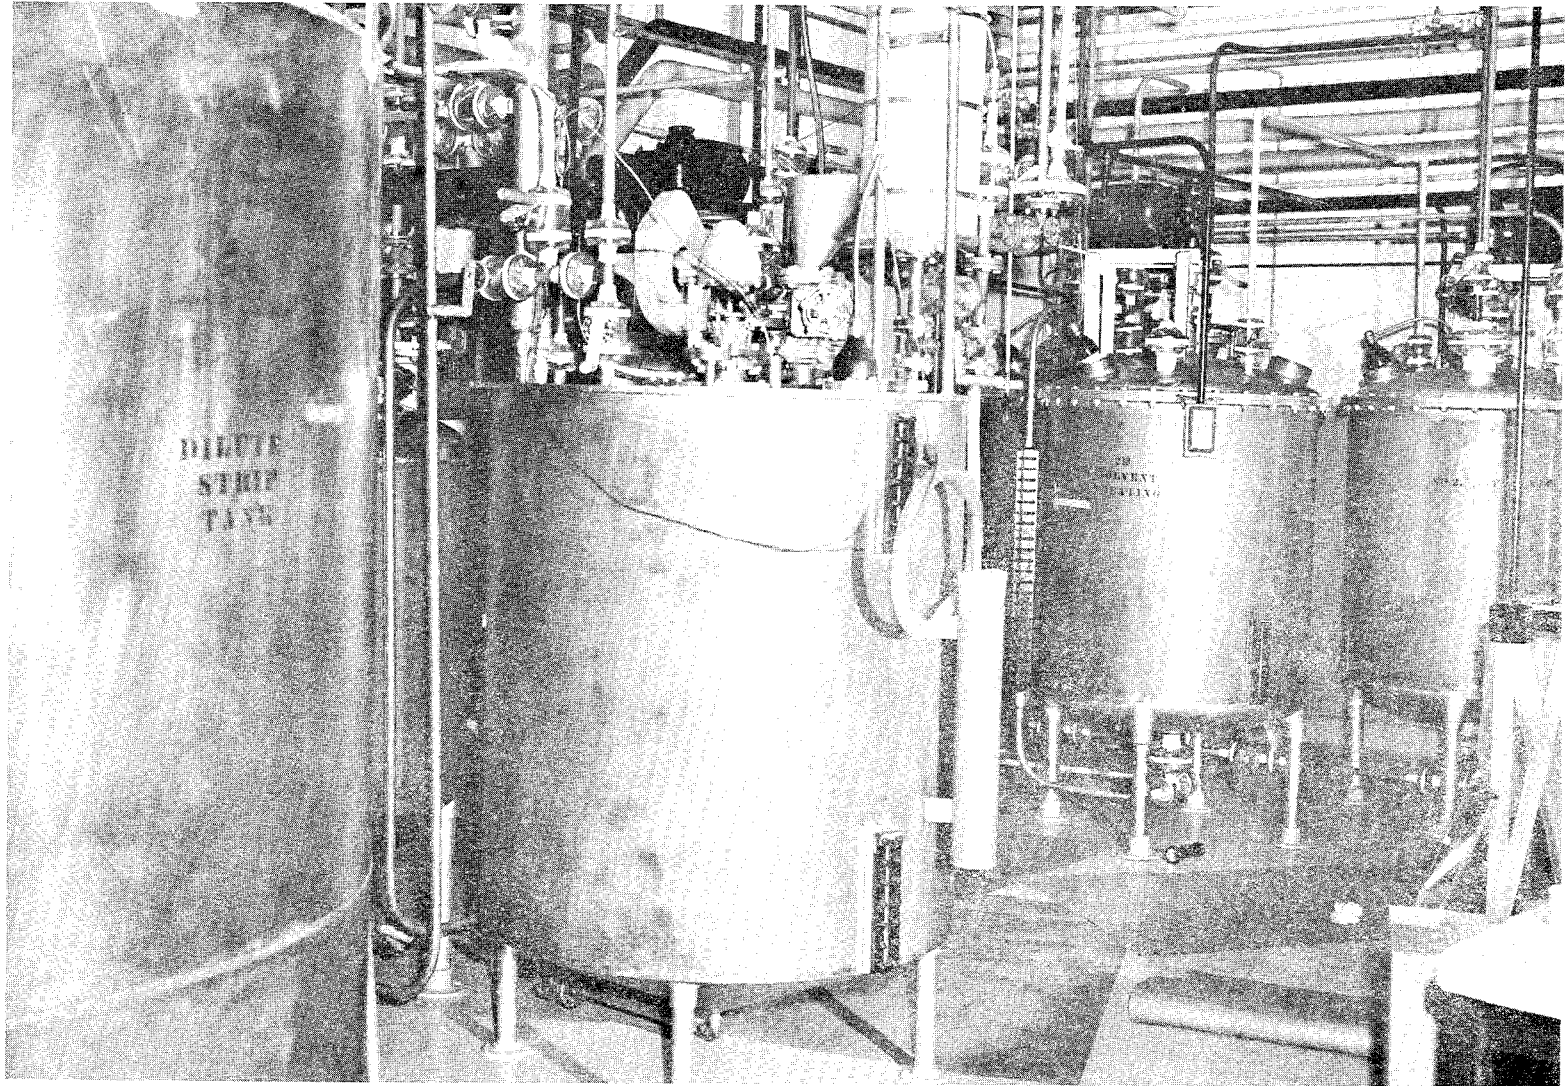
Fig. 10 218 Solvent Treating Tank.

Fig. 11 218 Solvent Treating Tank.

solvent layer on top of the solution. Subsequent transfer of this plutonium-rich solvent and the nitric acid slurry of residual solids in the bottom of the tank into the 218 Solvent Treating Tank (Figs. 10, 11, and 12) acidified the emulsion, freeing additional solvent for further extraction of any remaining hydrolysis products into the combined organic phase. As in the case of the Current Dilute Strip Tank, mixing and extraction resulted from the air-sparging of this material through the bottom inlet of this tank. Upon cessation of the air-sparging the solvent phase separated into an 8-in. layer on top of the aqueous which was subcritical at this time. This thickness was determined by evaluation of the solutions in the tank after the accident. Phase separation took about 2-1/2 minutes.

A chemical operator started the motor driving the mechanical agitator in the solvent-treating tank. There was a "blue flash" and a muffled report. The operator, who was looking into a sight glass at the top of the tank (Figs. 10 and 12), was knocked off the two-step ladder on which he stood. Though the shock displaced the tank about 3/8 inch at its supports, the tank was not ruptured and no plutonium escaped. The operator apparently turned the stirrer motor off, then on again (this time noticing a rumbling sound), ran out a nearby exterior door, and called that he was "burning up." A second operator, some 40 feet away in an adjoining room, saw a reflection of the light on the walls ("like a photo-flash"), heard the report, went to help, and was joined by a third operator. Returning to lead the first man to a shower (on request, apparently as the result of suspecting an acid burn), they passed the tank, and the second operator turned off the stirrer motor.

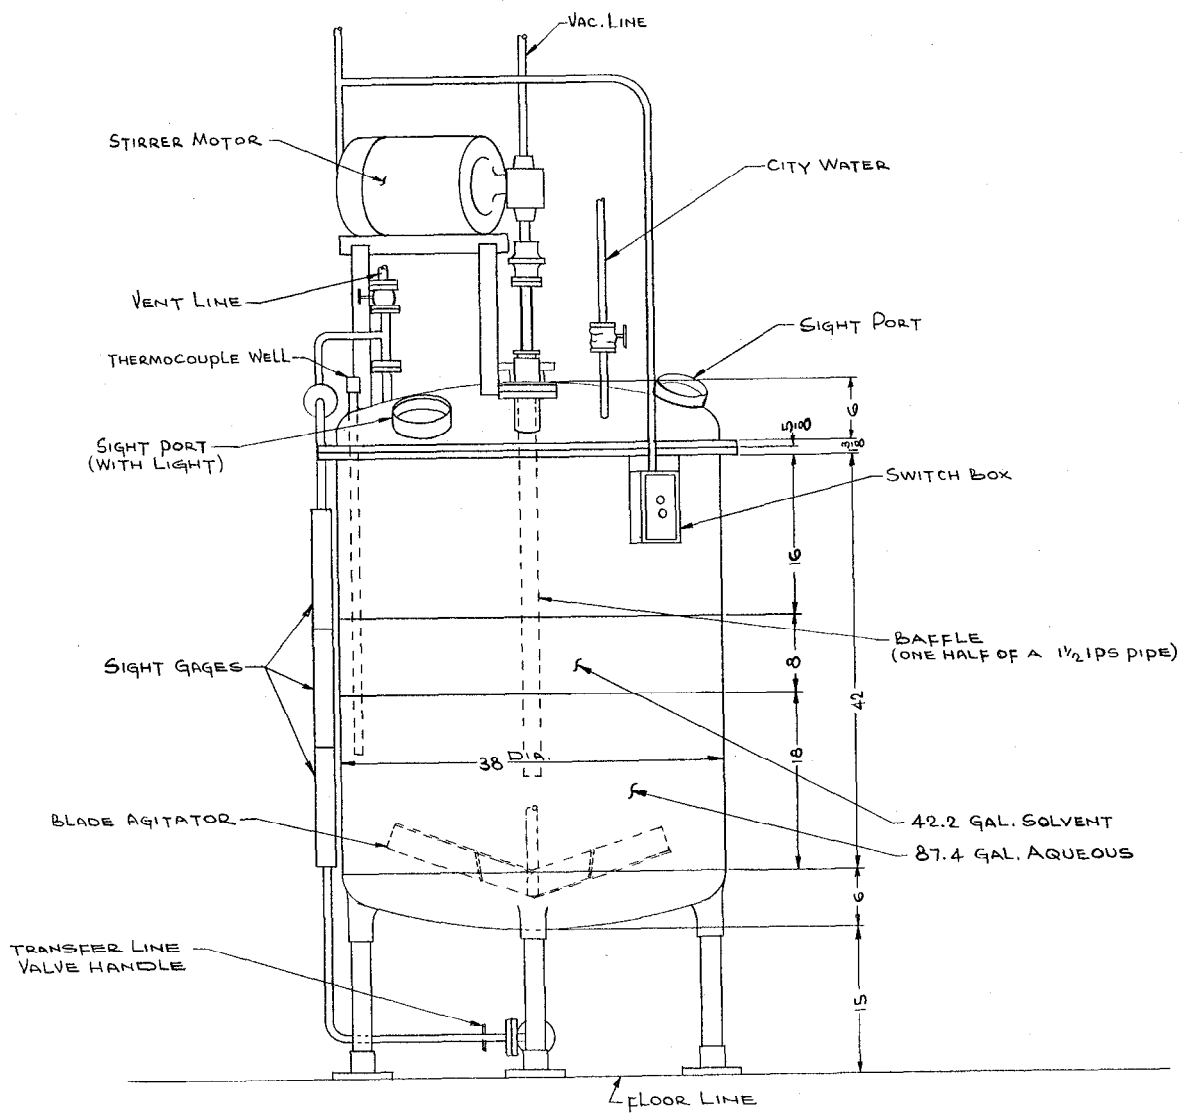
The situation in the 225-gallon, 38-in.-diameter, solvent-treating tank immediately before the accident is believed to be as illustrated in Fig. 12: 87.4 gallons of aqueous solution contained 40 g of Pu, and on top, a 42.2-gallon layer of solvent contained 3.27 kg of Pu. Solids (containing 60 g of Pu) were suspended in both the aqueous and organic phases and at the interface. Few solids settled to the bottom of the tank. Estimates based on Fig. 13, taking into account the tank diameter and effects of neutron "poisons," indicate that the 8-in.-thick solvent layer was barely subcritical at the plutonium concentration of 20 g/liter (the estimated critical thickness is 8-1/4 inches, and the actual configuration was roughly 5 dollars subcritical).

Fig. 12 Diagram of solvent-treating tank, showing levels of aqueous and organic phases before stirrer was activated.

The initial action of the stirrer in the solvent-treating tank forced aqueous solution up along the wall, displacing the outer portion of the solvent layer and thickening the central portion. An average increase in solvent-layer thickness of about 0.4 inch, corresponding to an average radius decrease of 1/2 inch, could account for the obviously supercritical configuration. The burst was certainly terminated by the violent disturbance that it generated, and continuation of the stirring diluted the plutonium beyond the point at which a critical reaction could recur.

Additional evidence that the plutonium was concentrated in the solvent layer when the burst occurred is given by the long-lived gamma activity of the stainless steel baffle (type-347) that was located about 6 inches within the wall of the solvent-treating tank (Fig. 12). Scanning indicated a peak in activity about 1 inch below the mid-plane of the solvent layer.

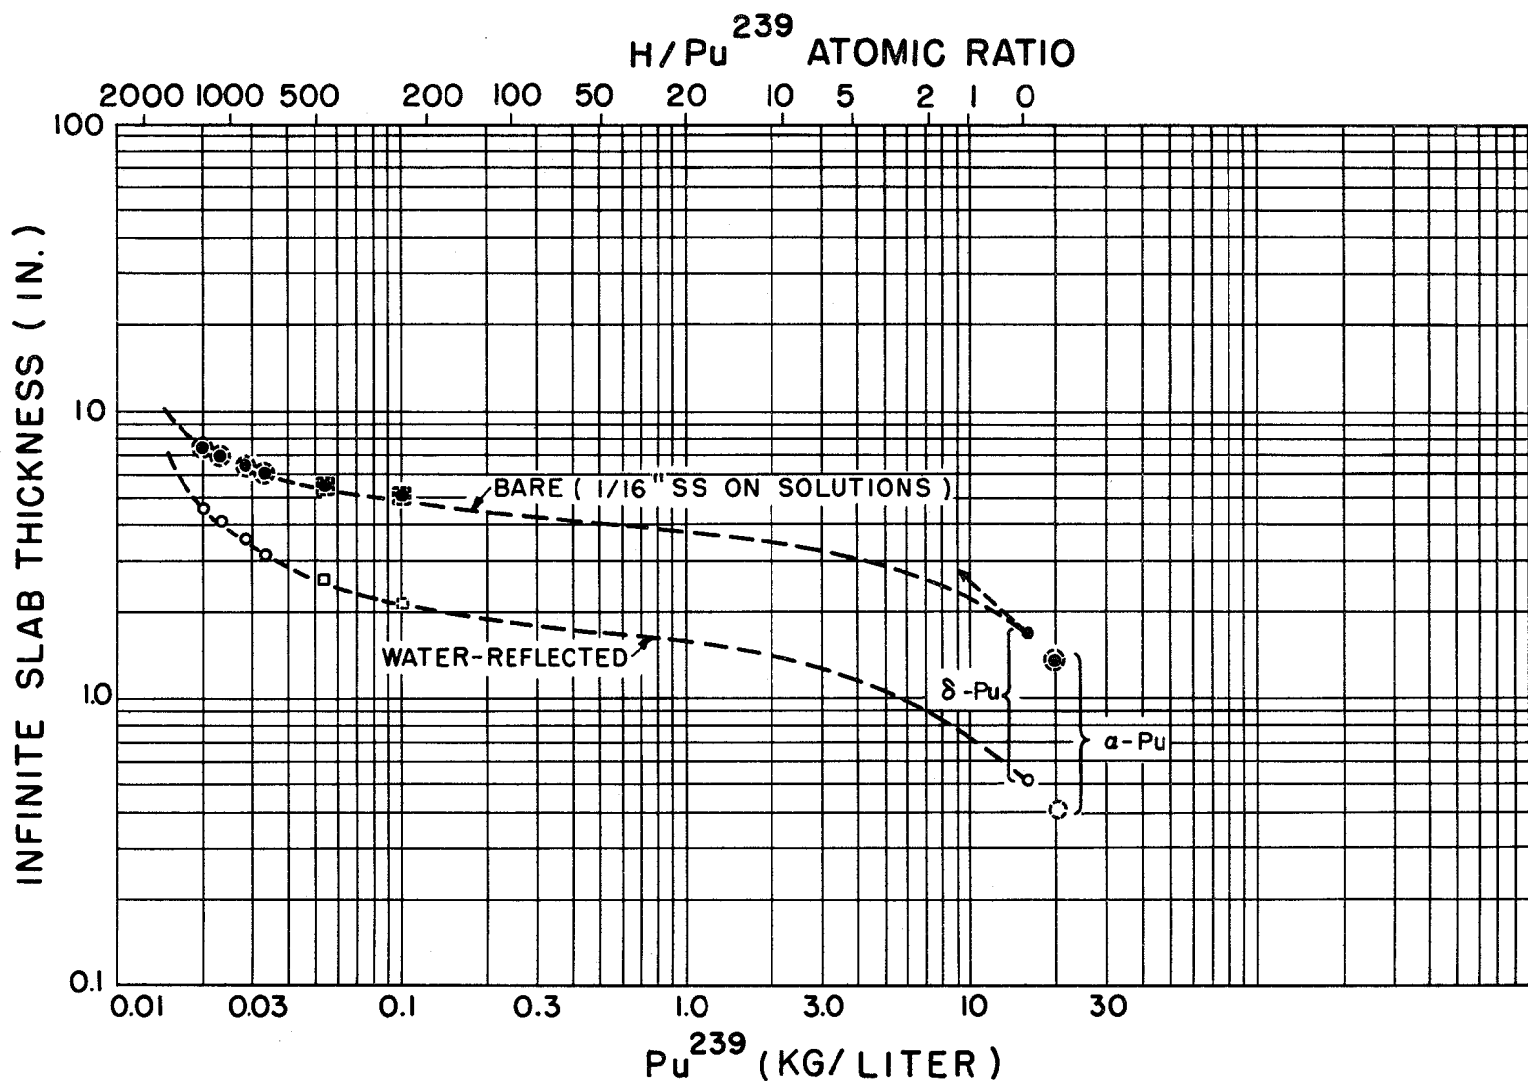
Fig. 13 Estimated critical thicknesses of infinite slabs of homogeneous water-moderated Pu²³⁹ in the absence of NO₃ and Pu²⁴⁰. Based on data from F. E. Kruesi, J. O. Erkman, and D. D. Lanning, Hanford Report HW-24514, May 1952 (classified).

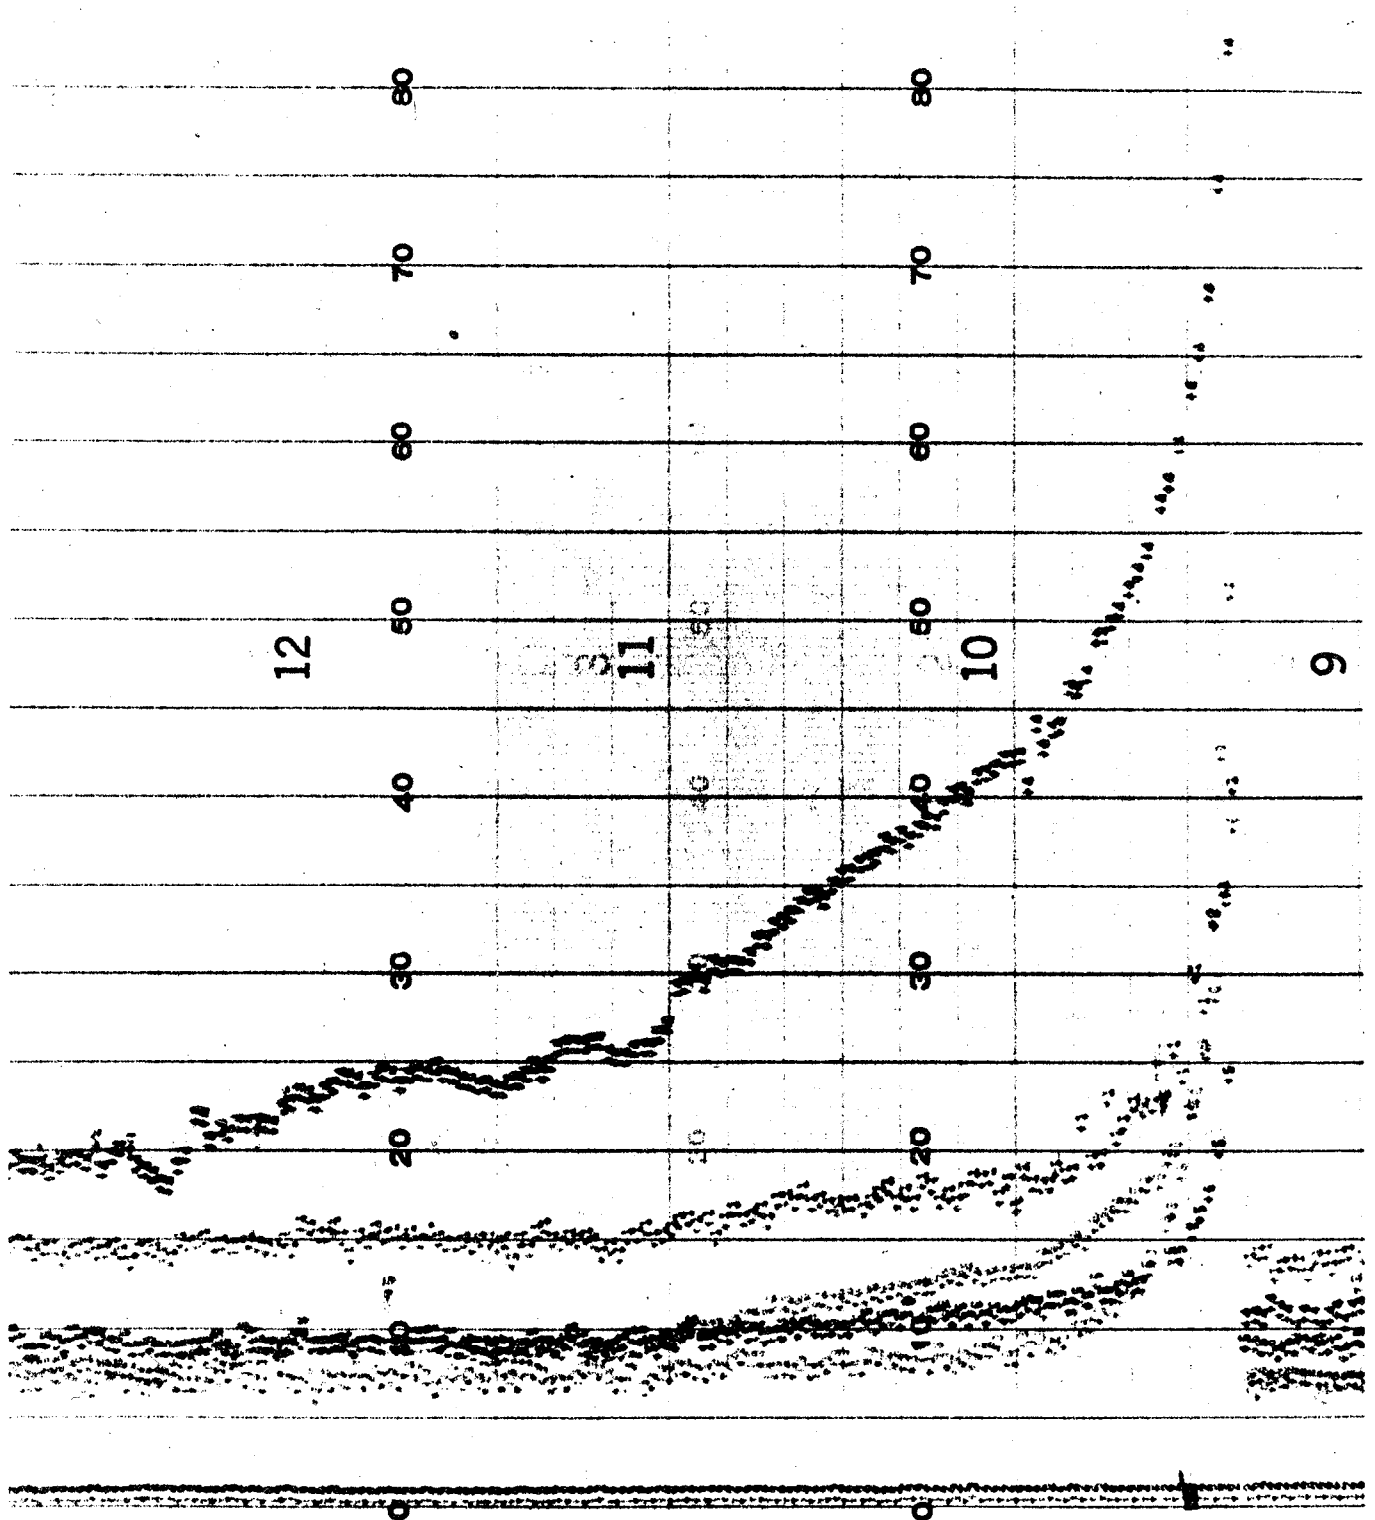
None of the gamma-sensitive recording detectors within range of the accident showed an ideal trace. They suggest, however, that there was but a single burst -- see, for example, the record reproduced in Fig. 14.

Fig. 14 Trace of slow-acting recorder (Point No. 4) located 160 ft from tank.

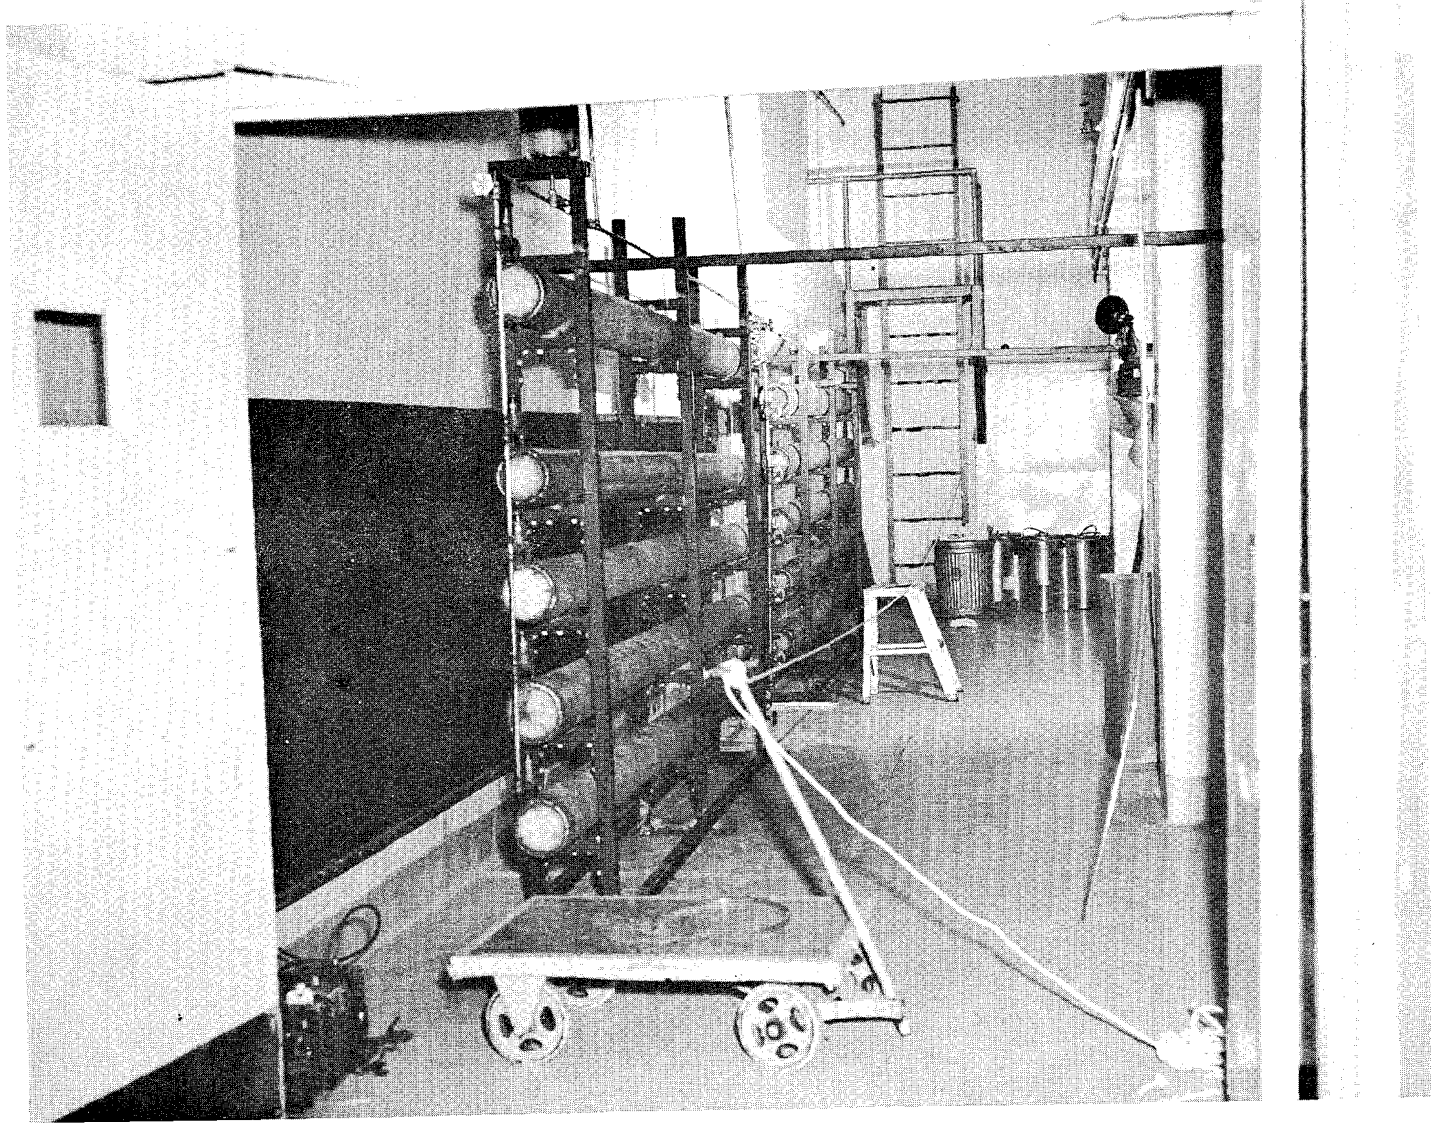
Immediately after the incident, a bank of ten 6- and 5-in.-diameter cylinders was fabricated and set up about 100 feet from the point of the accident (see Figs. 3, 15, and 16). This storage array was connected to a transfer line that leads from the bottom outlet of the solvent-treating tank. As the disposition of plutonium in the tank was then unknown, opening of the bottom outlet valve was a suspect operation and was therefore accomplished from behind a temporary shield by means of a 10-foot extension handle. The solution was vacuum-transferred into the bank of cylinders without complication on January 1, 1959. The solution level within the cylinders was followed by gamma-sensing instruments. Maximum reading at contact was about 1 r/hr, and indications along the wall of the solvent-treating tank immediately after emptying were less than 50 mr/hr.

Fig. 15 Geometrically-favorable tanks used to receive the solution.

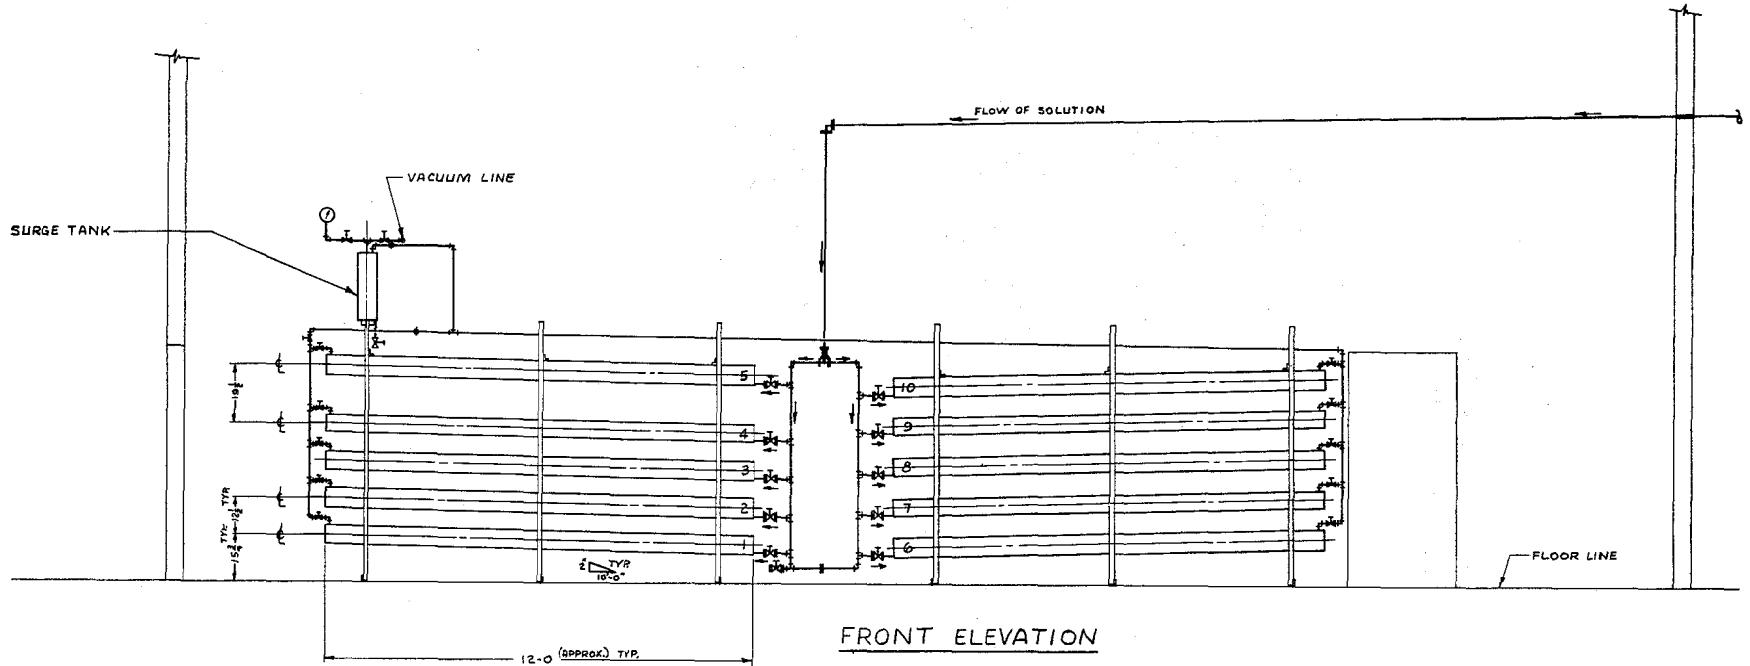
Fig. 16 Schematic diagram of geometrically-favorable storage cylinders.
