# Criticality incident at Windscale

By T. G. Hughes, BNFL, Windscale

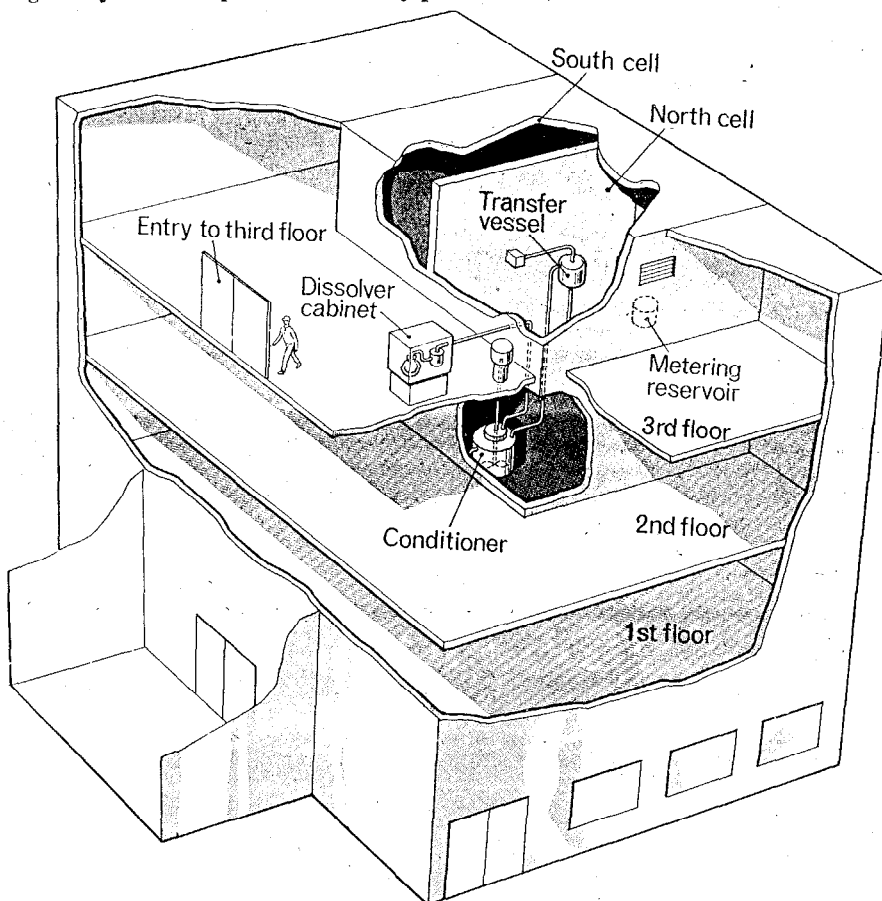
Fig. 1 Layout of the plutonium recovery plant

The plutonium recovery plant consists of two identical lines of equipment housed in separate cells with a common dividing wall. The cells are effectively concrete boxes with one foot thick concrete walls. Surrounding these walls on three sides is a conventional building shell, housing

the control equipment located on four floors. This is shown diagrammatically in Figure 1.

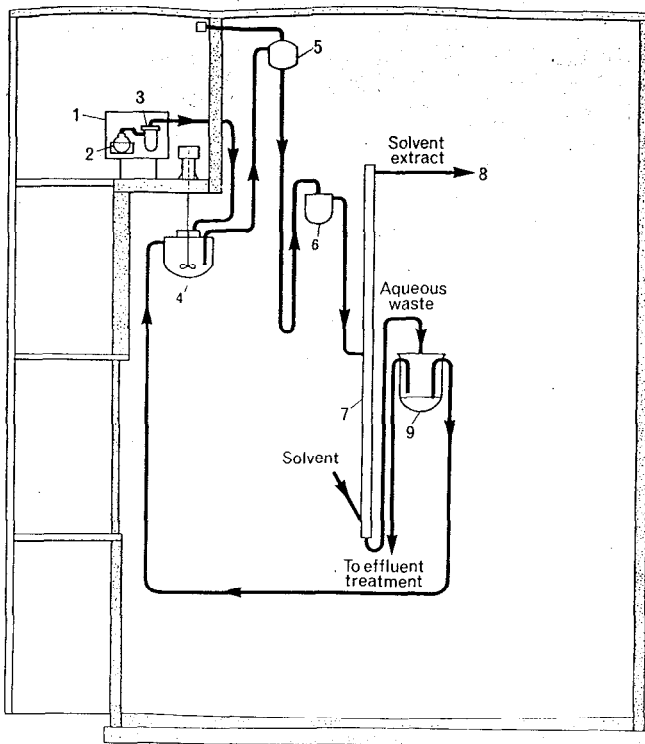
Fig. 2 Flow diagram for the plutonium recovery plant

A simplified line diagram of the main plant items of a processing line is shown in Figure 2. A glove box (1) located in the inactive operating area houses a glass vessel (2) in which plutonium residues may be dissolved in nitric acid. The solution produced may be passed via a filter (3) through the wall of the concrete cell to a stirred treatment vessel (4). Liquors from the latter may be lifted by the application of vacuum to a transfer pot (5). When all the liquor from the treatment vessel has been lifted into the transfer pot the vacuum breaks and the liquor may then flow via a tube into the metering reservoir (6).

(Plant items (1) to (5) are in fact duplicated but have been omitted from the diagram in the interests of clarity.) From here, the liquor may be metered to a pulsed column (7) for the first stage of solvent extraction which constitutes the purification process. In the column the plutonium is extracted from the aqueous solution by a solvent—TBP/kerosene—which rises through the column and leaves at point (8). The aqueous solution from which plutonium has been removed flows down the column and via a lute into a waste liquor collecting tank (9). Provision is made to enable liquors to be returned from this tank to the original treatment vessel (2) if for some reason the extraction of plutonium from the aqueous solution has been inadequate. When the incident occurred, only one of the processing lines, the so-called north unit, was in operation. The south unit was nominally clean of plutonium solution having been washed out with inactive reagents at the end of a previous campaign.

The re-entry survey had indicated that the seat of the excursion was in the region of the two treatment vessels and their associated vacuum lift pots. At the time the alarm sounded liquor was being transferred from one of the treatment tanks through the lift pot to the metering reservoir. In addition another batch of plutonium liquor was being treated chemically in the second treatment vessel. A sample of the latter was taken and indicated no

abnormality. However, a sample taken from the metering reservoir showed the presence of fission products that would have been produced by a nuclear excursion, although the plutonium concentration of this solution was only 6 gm/litre which was perfectly normal. Complete proof that the liquor in the reservoir was not the main source of fissile material responsible for the incident was established by siphoning the contents of the vessel into containers which were themselves safe by geometry and performing a complete analytical assay. Suspicion was therefore concentrated on the transfer pot (5). This vessel was positioned in the direct line of an air intake louvre in the cell wall through which radiation monitoring instruments could be introduced. The measurements taken confirmed that the incident had occurred in the transfer pot which almost certainly contained the bulk of the fissile material which had been critical.

pot contained an appreciable quantity of liquor. A conductivity probe was used to establish the precise depth of liquor in the vessel. This indicated a depth of 8½ in, equivalent to a volume of approximately 40 litre. On the basis of simple hydraulics the vessel should have been empty and the presence of liquid indicated a blockage at the outlet which could have arisen from an accumulation of solids in this area.

It was decided to empty the liquor from the transfer pot in 2½ litre aliquots using flexible plastic piping. This was achieved satisfactorily, the transfer being effected by siphoning to a collection point in an adjacent building. The first aliquot produced the complete explanation for the incident. The liquor was found to be a solution of plutonium nitrate in TBP/kerosene solvent. The solution had a specific gravity of 0.96 gm/ml and contained 55 gm plutonium/litre. It was now clear that at the point of criticality the vessel would have contained some 2½ kg plutonium in the combined 40 litre of solvent and the 50 litre of aqueous solution which was being transferred. The specific gravity of the aqueous liquor was 1.3 gm/ml, which, considering the geometry of the lute system, was high enough to ensure that the solvent, once having entered the transfer vessel, was locked there permanently. Subsequent examination of the empty vessel using the fibre optic equipment showed that the vessel contained virtually no solids and the outlet was not blocked.

Immediately following the incident a Board of Enquiry was set up consisting of experts from throughout the U.K. Atomic Energy Authority. The measures taken on the plant to establish the cause of the incident and to render the plant safe were endorsed by the Board. A report was produced making firm recommendations for plant modifications to prevent a recurrence of such an incident. The two most important of these were that neutron monitors should be installed on all vessels which are not safe by shape and that provision be made to enable luted plant items to be emptied completely.
