NUCLEAR CRITICALITY TECHNOLOGY

A Review of Criticality Accidents

William R. Stratton

March 1989

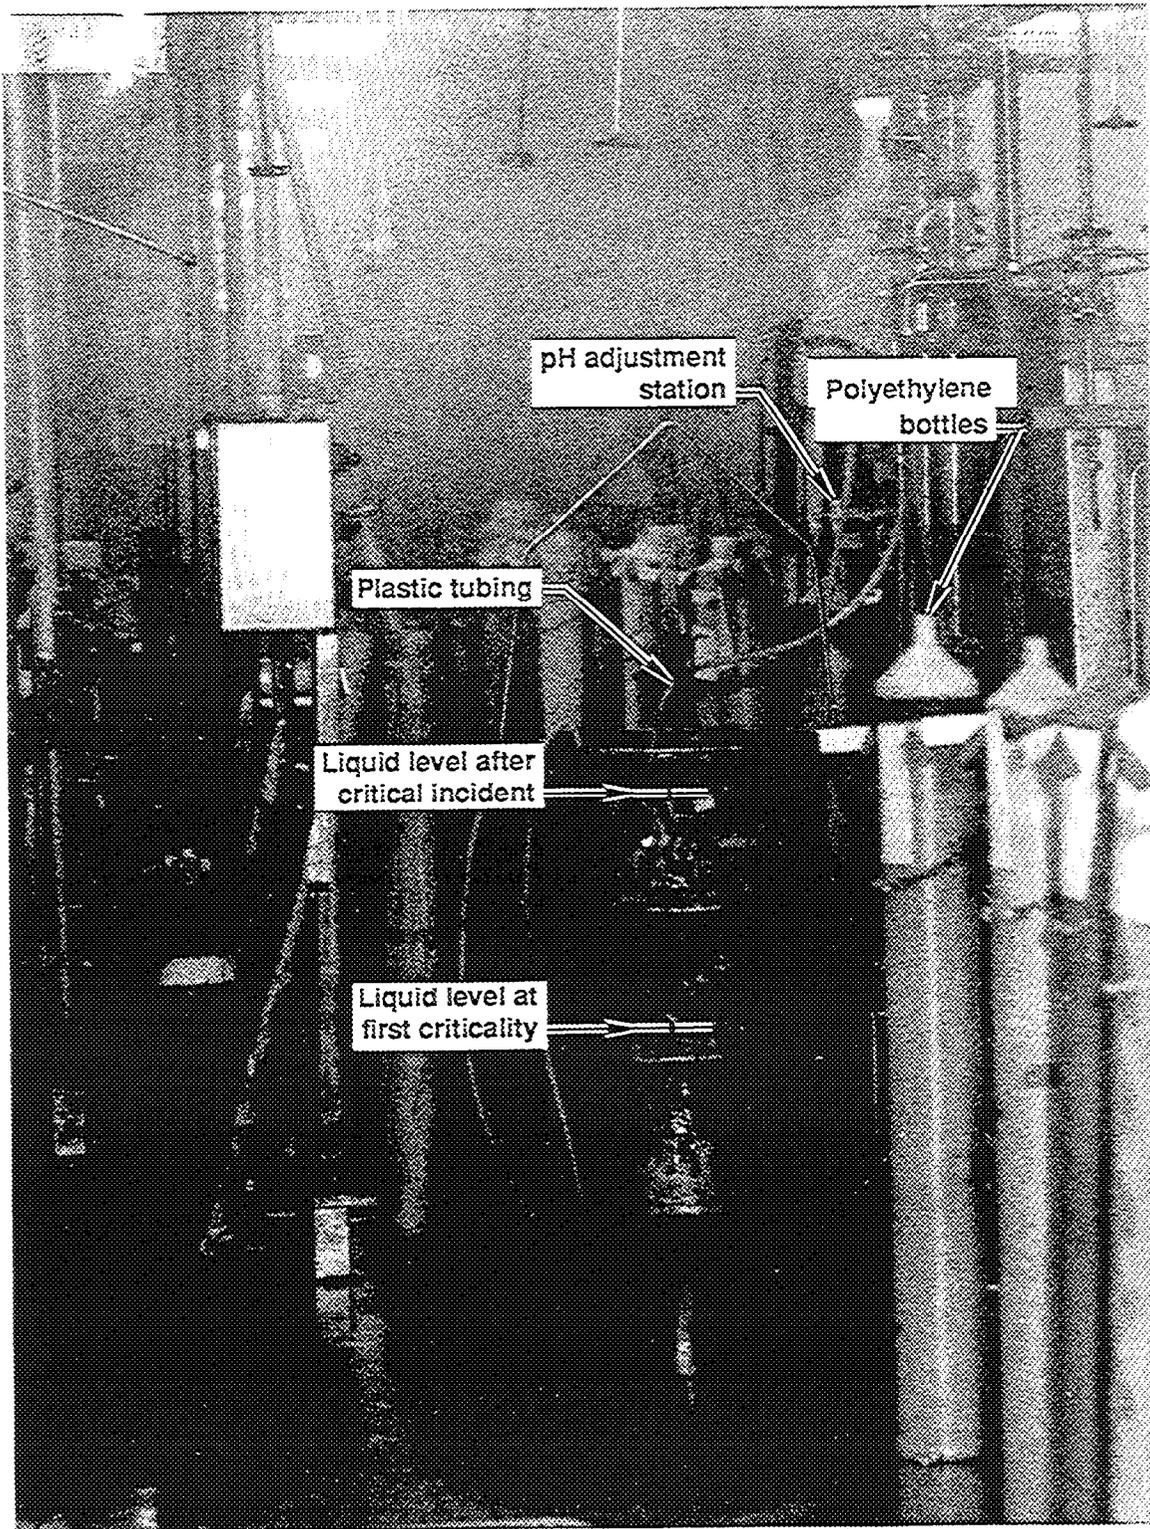
As a consequence of the overlapping operations and of irregularities in the operation of some valves, a quantity of enriched uranium solution was inadvertently transferred from the area already returned to operation into the one undergoing leak testing. The flow pattern from the storage pipes into a drum intended to receive water that had been used for leak testing was such that the accumulated solution preceded the water (Fig. 1). Because of its size, the 22-in.-diameter, 55-gal drum permitted the solution to become critical. Further flow of water increased the uncompensated reactivity* for about 11 min, then decreased it. The solution became subcritical after about 20 min.

Fig. 1. 55-gal drum in which the 1958 Y-12 process accident occurred.

During this incident, 1.3×10^{18} fissions occurred. There was no damage or contamination. Eight people received radiation doses (461, 428, 413, 341, 298, 86.5, 86.5, and 28.8 rem). At least one person owes his life to the fact that prompt and orderly evacuation plans were followed. One person survived 14-1/2 years; one 17-1/2 years; the status of one is unknown; and five were alive 29 years after the accident.

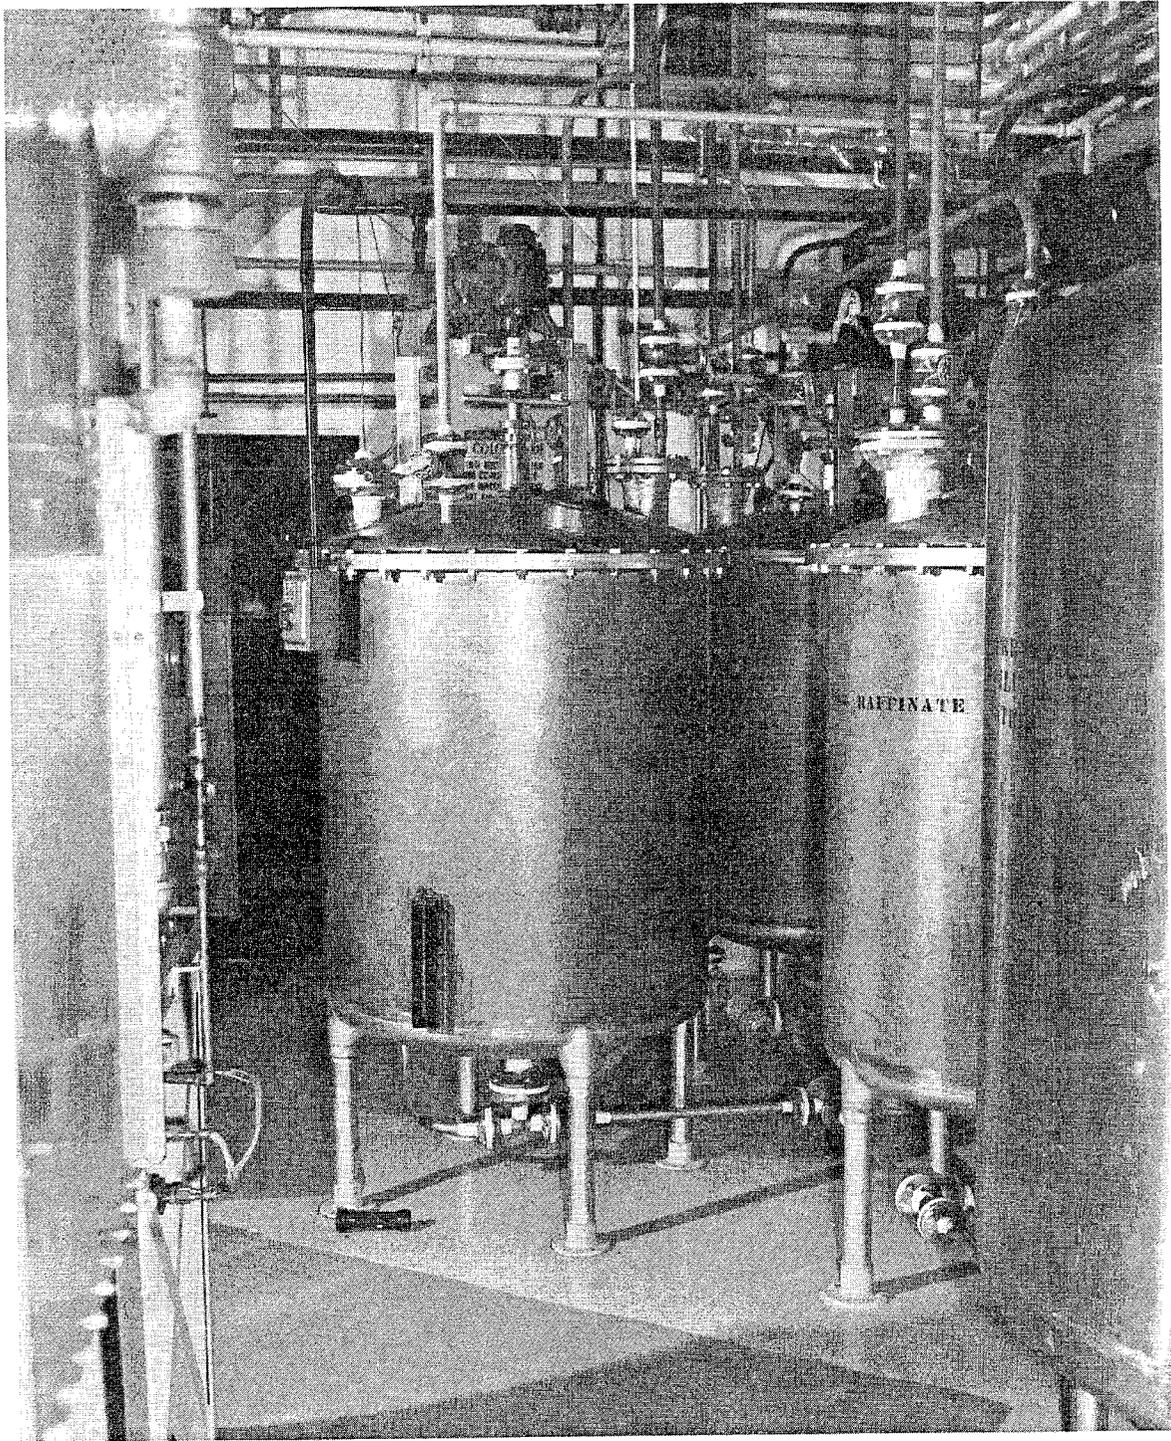
The accident resulted in the death, 36 h later, of the operator who was looking into a sight glass when the motor was turned on. His radiation dosage was estimated to have been 12,000 ± 50% rem. Two other persons apparently suffered no ill effects after receiving radiation doses of 134 and 53 rem. No equipment was contaminated or damaged even though the shock displaced the tank about 1 cm at its supports.

Fig. 2. Process vessel in which the 1958 Los Alamos plutonium solution accident occurred.

The entire plutonium process area had been reviewed by the Laboratory Nuclear Criticality Safety Committee about a month before the accident. Plans were underway to replace the large-volume process vessels with more favorable-geometry vessels. Administrative controls that had been used successfully for more than 7 years were considered acceptable for the additional 6 to 8 months that would be required to obtain and install the improved equipment.

Following the accident, procurement of favorable-geometry equipment was accelerated and installation was completed prior to restarting operations. To

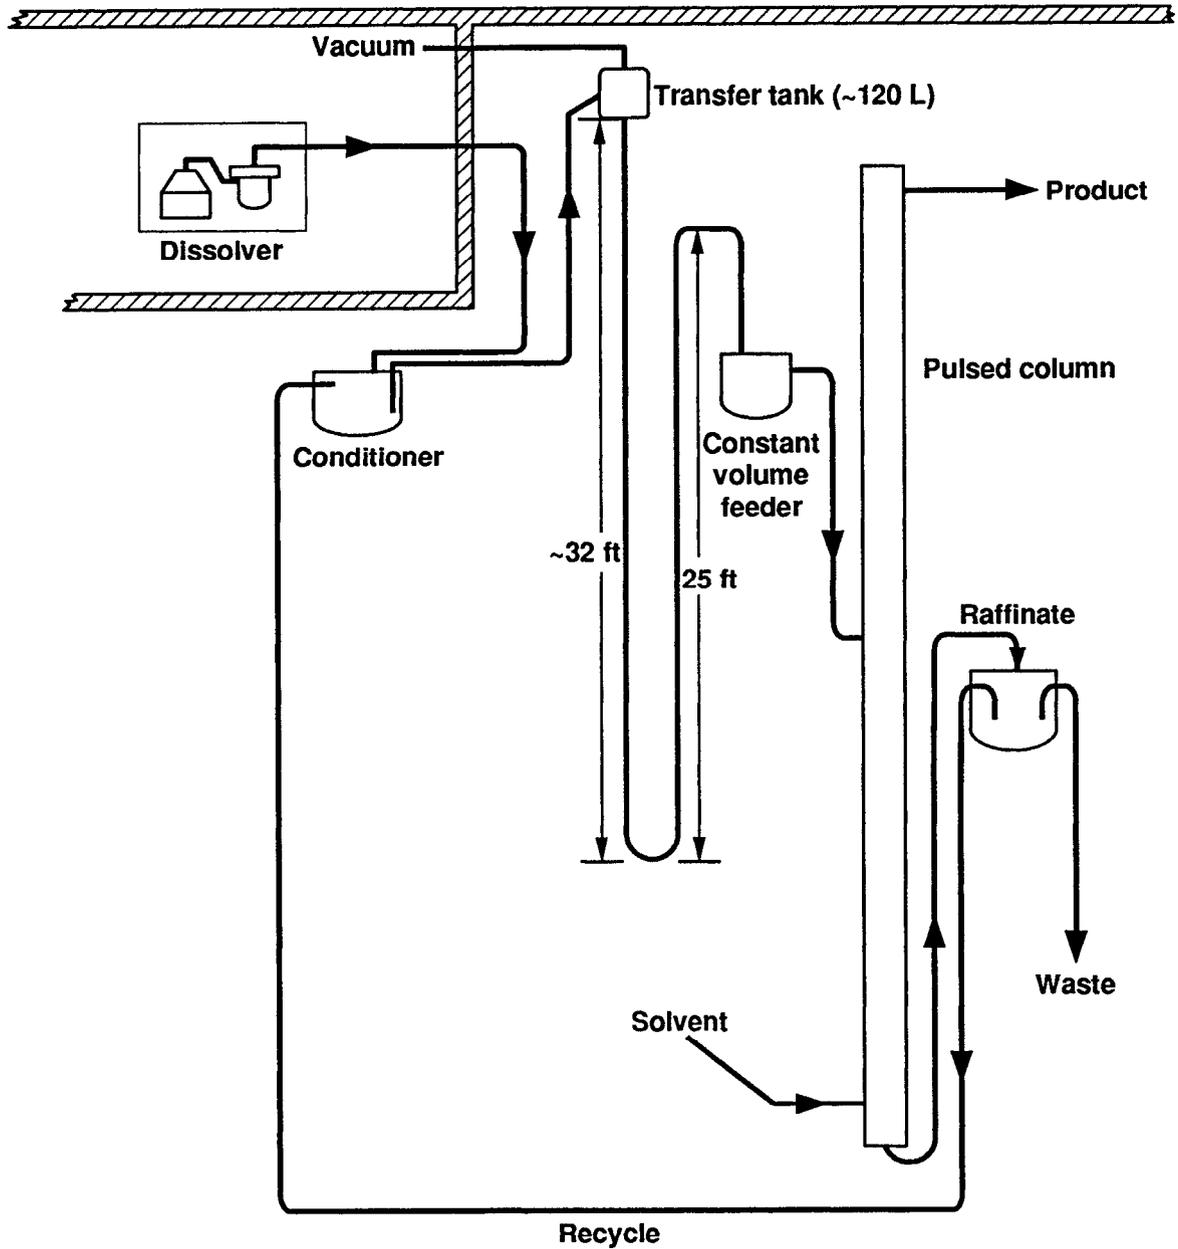
The solution was vacuum-lifted from the conditioner to a transfer tank (Fig. 4). When the transfer was completed, the vacuum was broken and the transfer tank was allowed to drain into a constant-volume feeder that supplied a favorable-geometry, pulsed, solvent-extraction column. The connection from the transfer tank to the constant-volume feeder was through a 25-ft-deep trap, or lute, that prevented any potential backflow and thus controlled contamination.

The excursion occurred on completion of the transfer of a 50-L batch of solution from the conditioner to the transfer tank. The small size (10^{15} fissions) and brief duration (<10 s) of the excursion precluded the activation of any energy-based shutdown mechanism. Radiation measurements indicated the excursion occurred in the transfer tank, but the solution from the conditioner was too lean to sustain criticality and the total quantity of plutonium in the batch (300 g) was about 60% of the minimum critical mass. Thus, it was feared that the transfer tank might contain large quantities of solids, perhaps tens of kilograms and that any disturbance of the system might stimulate another, possibly much larger, excursion.

A 6-in.-diameter hole was cut through the concrete roof, and the vacuum line to the transfer tank was opened. The interior of the transfer tank was inspected with a fiber-optics system (developed specifically for this recovery operation) and was found to contain liquid. A small-diameter plastic line was inserted into the tank and 2-1/2 L aliquots were siphoned to a collection point in an adjacent building. Inspection of the liquid revealed tributyl phosphate and kerosene with a specific gravity of 0.96 g/mL and containing 55 g Pu/L. Aqueous liquor from the conditioner had a specific gravity of 1.3. A 25-ft column of aqueous liquor in one arm of the trap was sufficient to balance approximately 33.8 ft of solvent in the other arm. Thus any solvent introduced into the transfer tank was held in the arm and could accumulate until the volume of solvent corresponded to a height of 33.8 ft above the bottom of the trap. Some 39 L, containing about 2.15 kg Pu, were present. Degradation of the solvent indicated it had been trapped in the transfer tank for several months, and perhaps for as long as two years.

Fig. 4. The British Nuclear Fuels, Ltd., process line at Windscale.

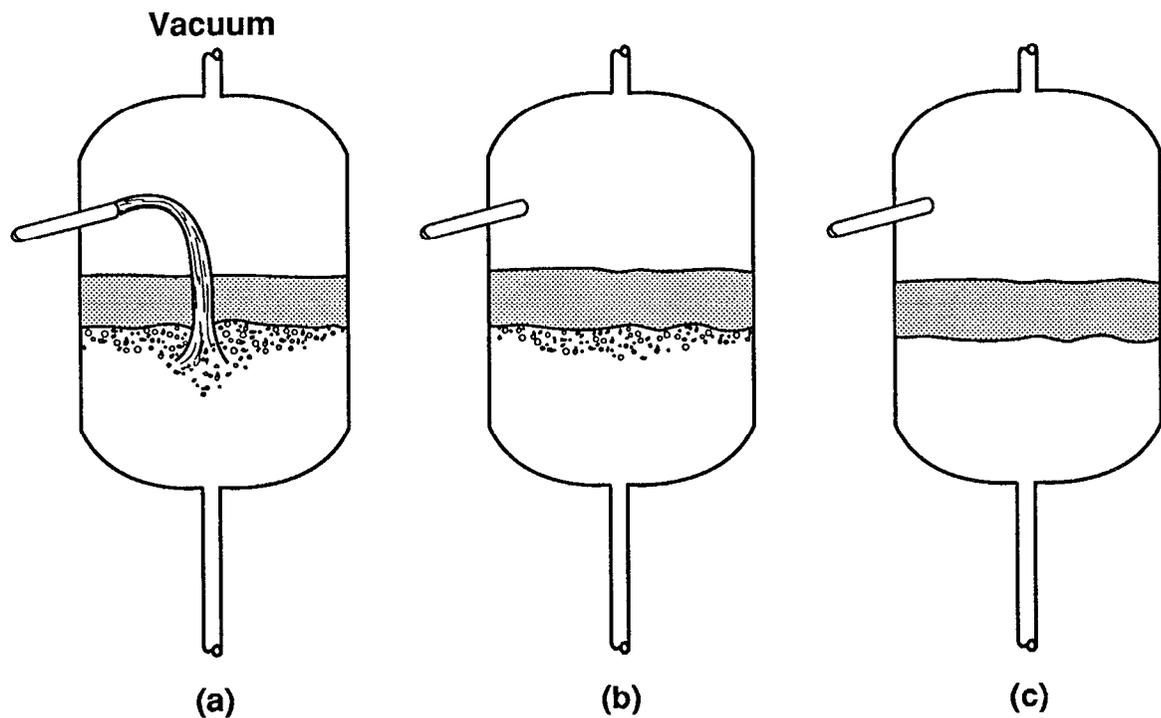
A transparent plastic mockup of the transfer tank was used to observe the configuration of the liquids during transfer. The situation existing during the transfer is shown in Fig. 5a. Rich organic (55 g/L) is floating on top of lean aqueous liquor (6 to 7 g/L). The aqueous stream pouring into the center of the tank provides a region of low reactivity. Between the organic and aqueous is a region of mixed phases, about 3 in. thick near the axis of the tank. This configuration is subcritical.

Just after completion of the transfer (Fig. 5b) the central plug of aqueous liquor has disappeared, the region of mixed phases is still present, and the configuration has a maximum value of the multiplication factor. Separation of the two phases occurs within a few seconds of completing the transfer (Fig. 5c). Monte Carlo calculations have indicated that the reactivity of Fig. 5b is about 5 $ greater than that of Fig. 5a and about 10 to 15 $ greater than Fig. 5c.

Fig. 5. Solution transfer in the Windscale process line.

Apparently, there was sufficient time between nitric acid washes for the plutonium concentration to increase until the system became slightly supercritical at the conclusion of a transfer, tripping the criticality alarms.

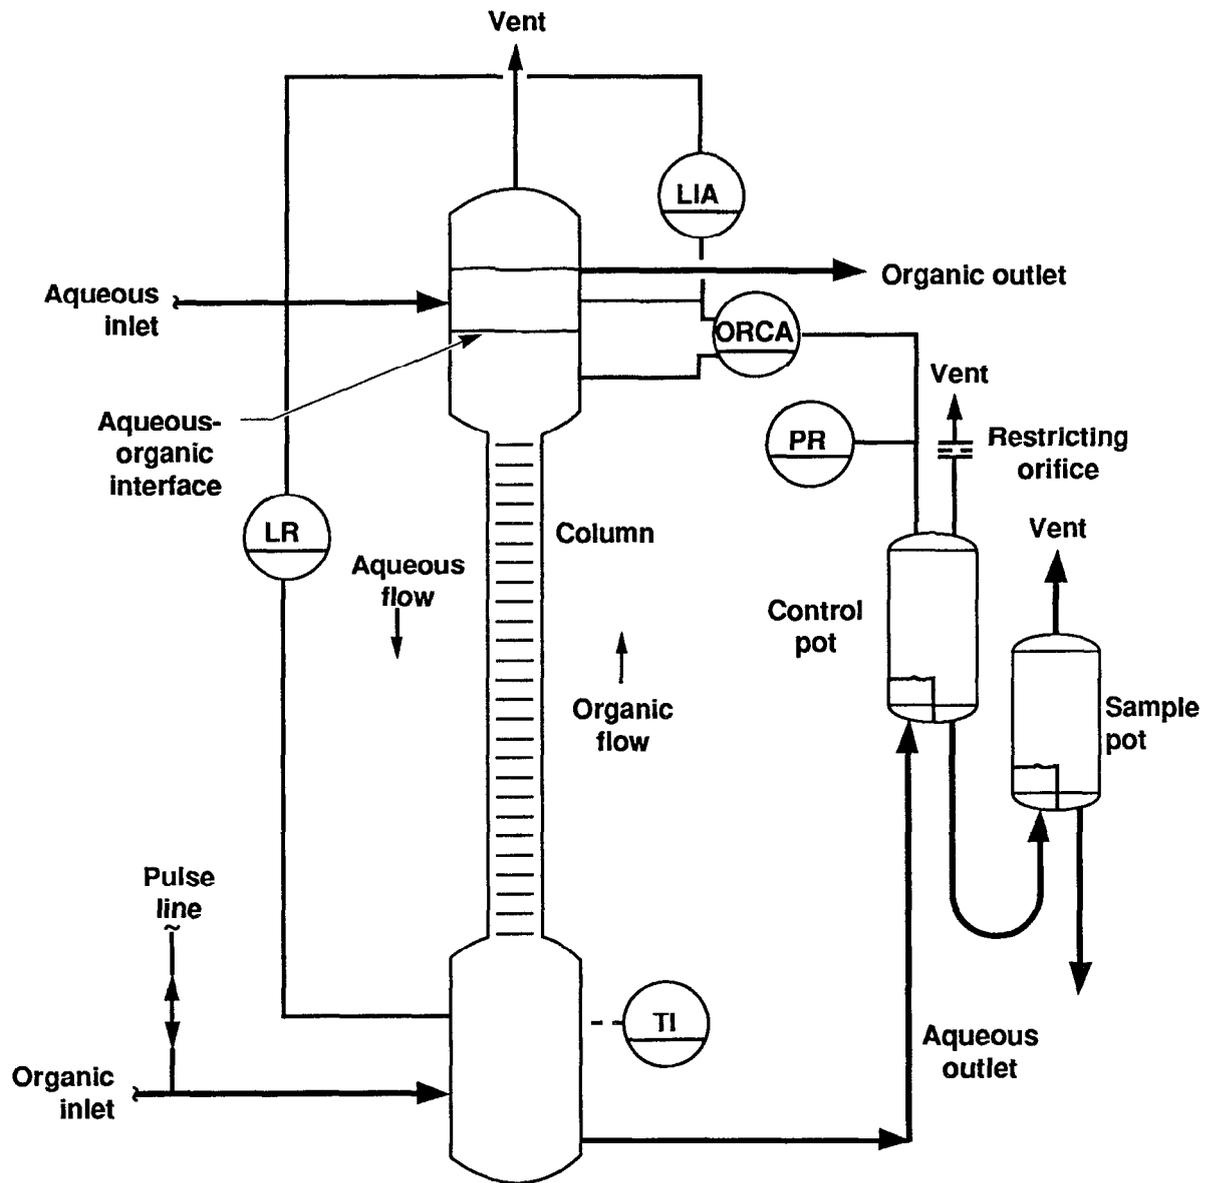
Fig. 6. H-100 Scrub Column.

The out-of-specification aqueous feed to the scrubbing column caused it to operate as a stripper rather than as a scrubber. Some of the enriched uranium was removed from the column 1B organic and recycled into the input of column 1A. This partially-closed loop resulted in a steady increase in the uranium inventory in the two columns. Each time diluted solution was added to the feed tank from the makeup tank, the aluminum nitrate concentration in the feed was further reduced and stripping became more effective until the excursion occurred.

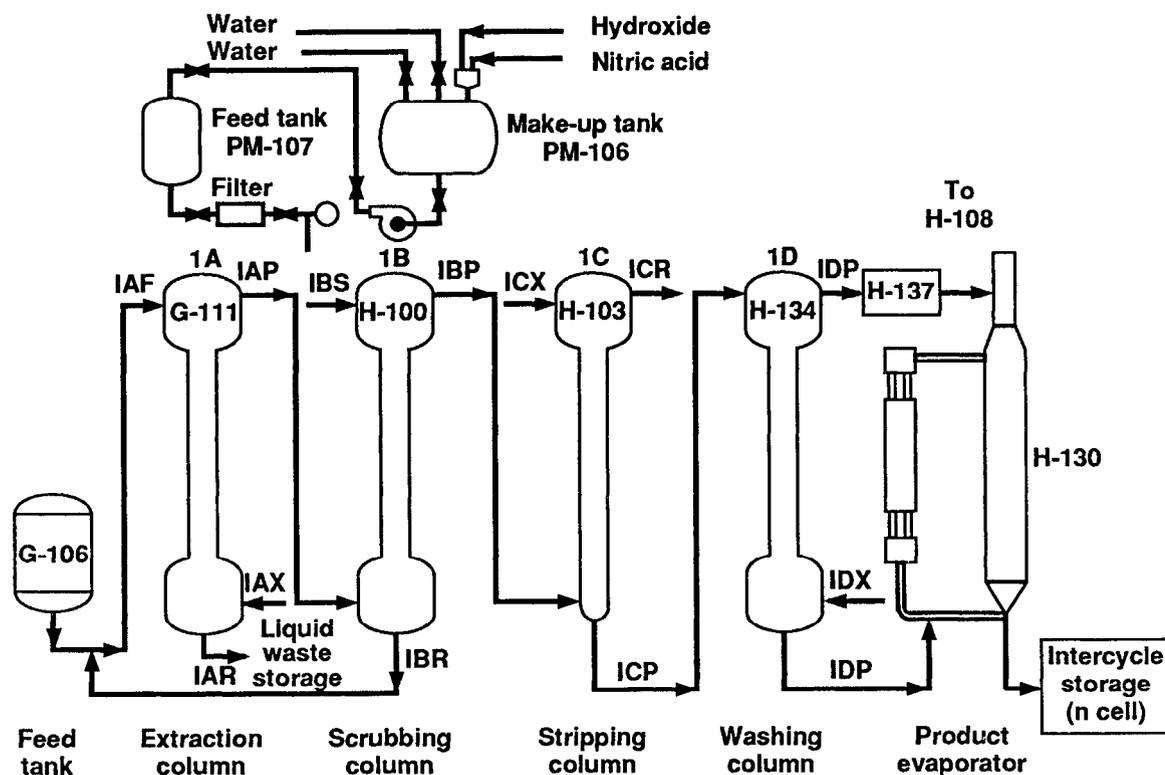
Several factors contributed to this accident. An evaporator had plugged, and operations had been suspended for several weeks while instrumentation difficulties were corrected. During the downtime, a valve leaked water into the aluminum nitrate makeup (PM-106) tank used for preparation of the aqueous feed to the scrubbing stage (1B). This leak, over time, caused a dilution of the feed solution from $0.75M$ to $0.08M$. The 13,400-L makeup tank was equipped with a density gauge

Fig. 7. First-cycle extraction line, Idaho Chemical Processing Plant.

that would have indicated the discrepancy, but the gauge was inoperable. A density gauge was scheduled to be installed on the 3,000-L process feed (PM-107) tank that was filled, as necessary, from the makeup tank, but this had not been done. The makeup tank was instrumented with a strip-chart recorder showing the solution level in the tank, but the leak into the tank was so slow that the change in level was not discernible without pulling out several days of the chart length. Procedures required that the density in the process feed tank be obtained after each transfer from the makeup tank. Results of sample analyses were not available until after the accident.

There was no significant personnel exposure and no damage to process equipment. As a direct result of this event, the plant suffered an extended and expensive shutdown; all operating procedures were reviewed in detail and revised as appropriate. Increased emphasis was given to plant maintenance and operator training. An extensive and highly instrumented plant protection system involving redundant sensors and redundant, automatic safety controls was installed.

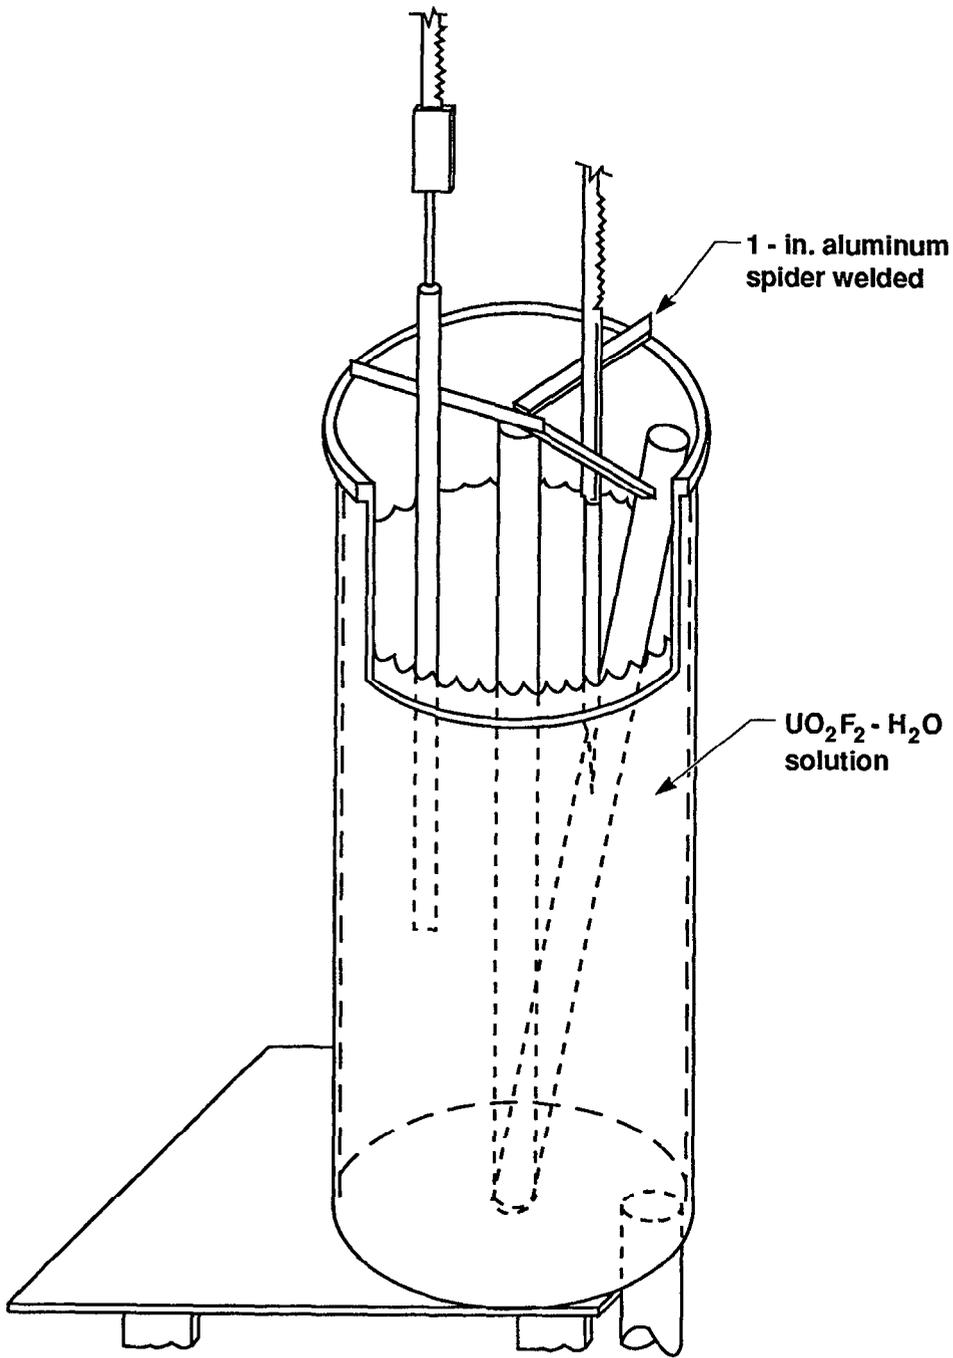
Fig. 8. The ORNL uranium solution assembly showing the normal and
detached positions of the central poison rod.

In this case the analysis was directed to finding what reactivity insertion rate would cause a power spike of the required yield. The analysis was then examined to see if it contradicted any known facts. It was found that a rate of 94 $/s was adequate to cause a spike of 8 ms duration, which would account for the observed yield. The maximum excess reactivity would be about 2 $ over prompt criticality; the void volume could be 12 times that of the ORNL May 26, 1954 accident (II-A. 3), thus easily accounting for the splashing of the solution. The void volume that results as microbubbles (caused by disassociation of water by fission fragments) coalesce is discussed in *III. Power Excursions and Quenching Mechanisms*.

A laborious chemical decontamination of the assembly room was required to clean up the ejected solution. Slight mechanical damage was evidenced by distortion of the bottom of the cylinder. No one received a radiation dose greater than 0.6 rem.

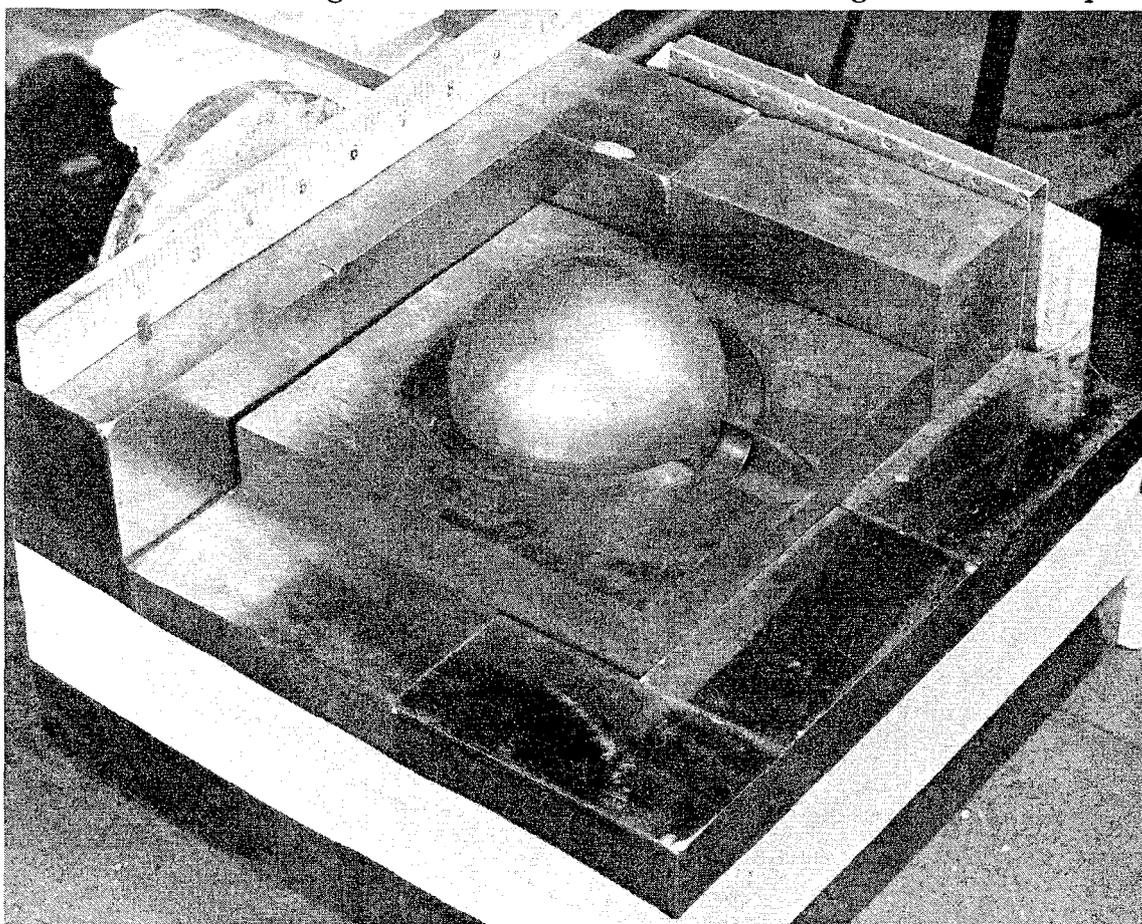
In the first accident, a critical assembly was being created by hand stacking 4.4 kg tungsten-carbide bricks around the plutonium core. Figure 9 shows a reenactment* of the configuration with about half of the tungsten blocks in place.

Fig. 9. Plutonium sphere partially reflected by tungsten-carbide blocks.

An Army guard assigned to the building, but not helping with the experiment, received a radiation dose of approximately 50 rem. The nickel canning on the plutonium core did not rupture.

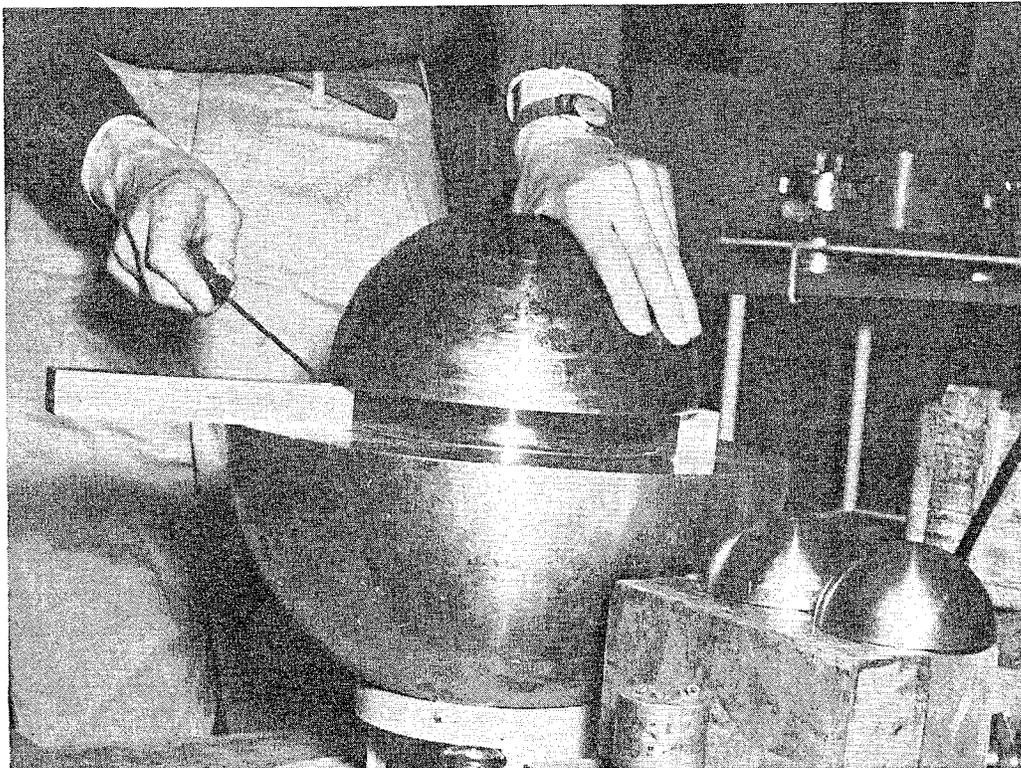
In the second accident, the techniques involved in creating a metal critical assembly were being demonstrated to several people. The system consisted of the same plutonium sphere reflected, in this case, by beryllium. The top and final hemispherical beryllium shell was being slowly lowered into place; one edge was touching the lower beryllium hemisphere while the edge 180° away was resting on the tip of a screwdriver (Fig. 10). The person conducting the demonstration was holding the top shell with his left thumb placed in an opening at the polar point, while slowly working the screwdriver out with his right hand when the screwdriver slipped and the shell seated on the lower hemisphere. An excursion occurred at once, the shell was thrown to the floor, and all personnel left the room.

Fig. 10. Configuration of beryllium reflector shells prior to the accident May 21, 1946.

The yield of this excursion was 3×10^{15} fissions; again, there was no rupture of the nickel canning. The eight people in the room received doses of about 2100, 360, 250, 160, 110, 65, 47, and 37 rem. The man who performed the experiment died 9 days later.

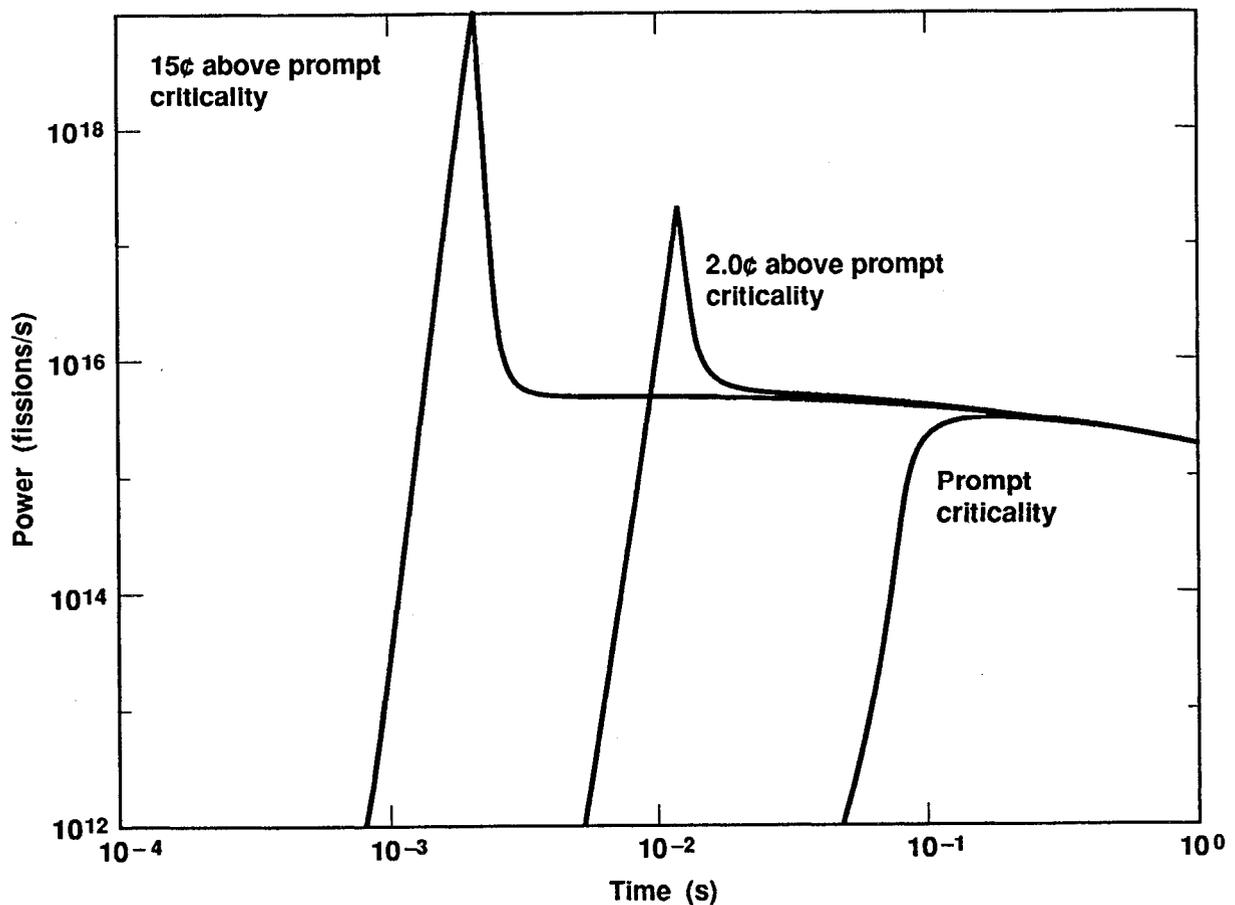
Fig. 11. Calculated fission rate for 6.2-kg plutonium sphere.

The results of calculations of the fission rate in this sphere, as a function of time for several values of excess reactivity, are shown in Fig. 11. Fig. 12 represents the total number of fissions to be expected as a function of time for the same excess reactivities.* These data are applicable to both accidents because the difference in reflector material has only a small effect on the neutron kinetics. In the first excursion, if the excess reactivity did not exceed 0.15 $, the assembly must have been together for several seconds, which is not unreasonable. In the second event, the experimenter was better prepared to disassemble the material, and it is thought that this was done in a fraction of a second, perhaps less than 1/2 s. The known parameters would then be satisfied by an excess reactivity of about 0.10 $.

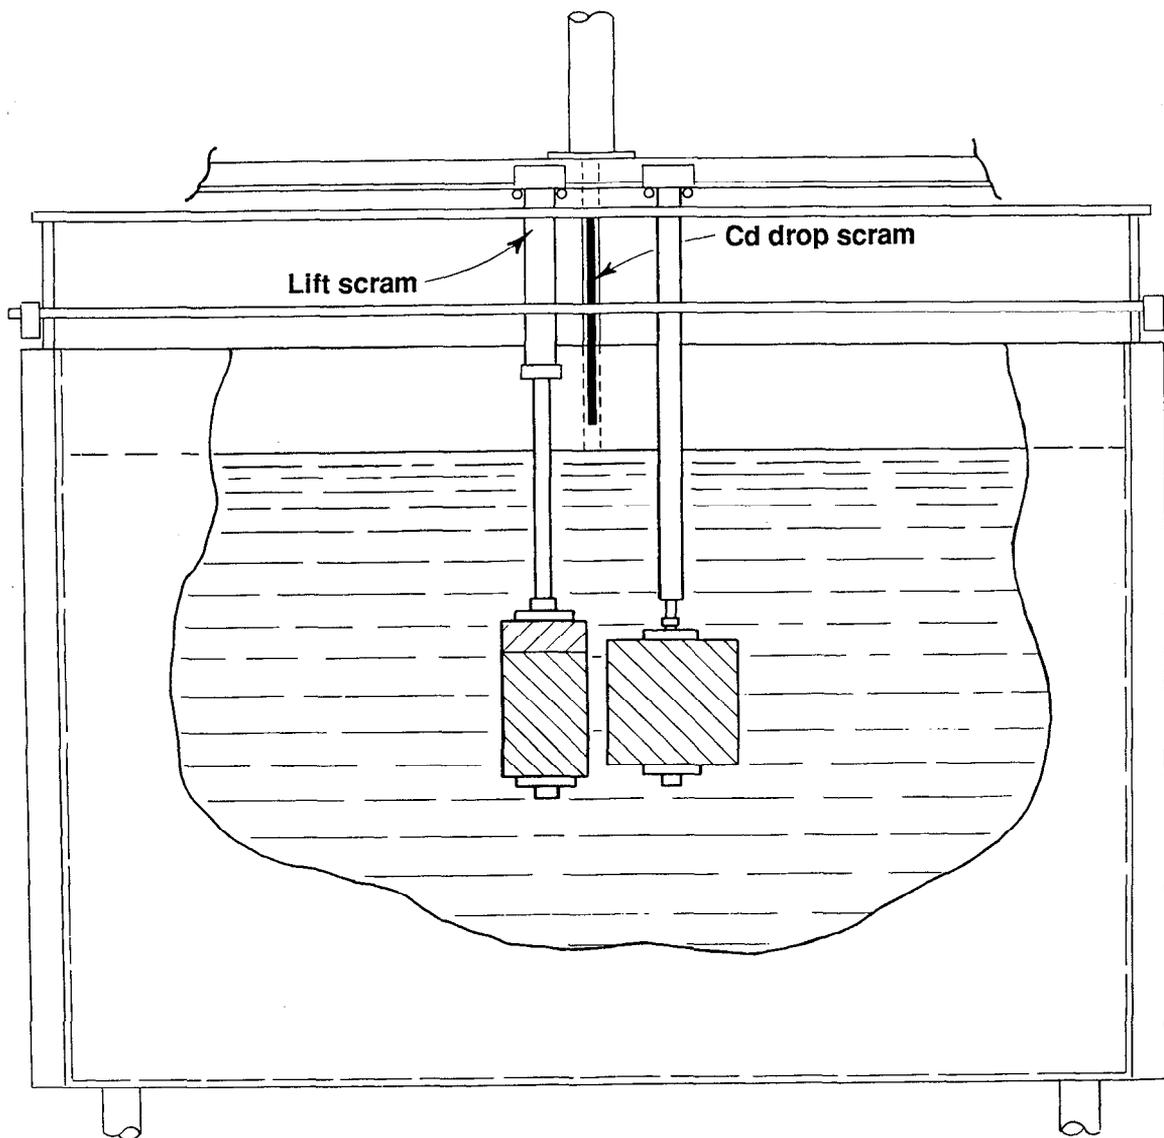
Fig. 13. The LASL aquarium assembly machine employed for measurements of critical separation distances.

At the completion of the critical separation experiment (at a multiplication* of 65.5), the assembly was scrammed as a final flourish. The water started draining, the cadmium screen dropped, the solid cylinder (left-hand body in Fig. 13) was lifting, and an excursion (later determined to be 10^{17} fissions) was made evident by jamming of neutron counters and the appearance on television of a vapor cloud above the water.

Later reconstruction of the accident showed that the pneumatic tangential scram was the first to be effective and led directly to two types of difficulty. First, the center of reactivity of the left-hand cylinder (Fig. 13) proved to be below that of the stationary cylinder and, second, the rapid lift through the water created Bernoulli forces that swung the cylinders closer together. The combination of the two effects was enough to drive the assembly prompt critical and to have maintained this or a greater reactivity for 0.2 s if the power excursion had not occurred. The first power spike is estimated to have contained 6×10^{15} fissions. It is possible that one or more excursions into the prompt region followed because boiling was the primary quenching mechanism.

In this excursion of 10^{17} fissions, no radiation doses were received, and no contamination was found in the experimental area. Damage to the uranium consisted of a small amount of oxide flaking and blistering. The experimental area was in use two days later.

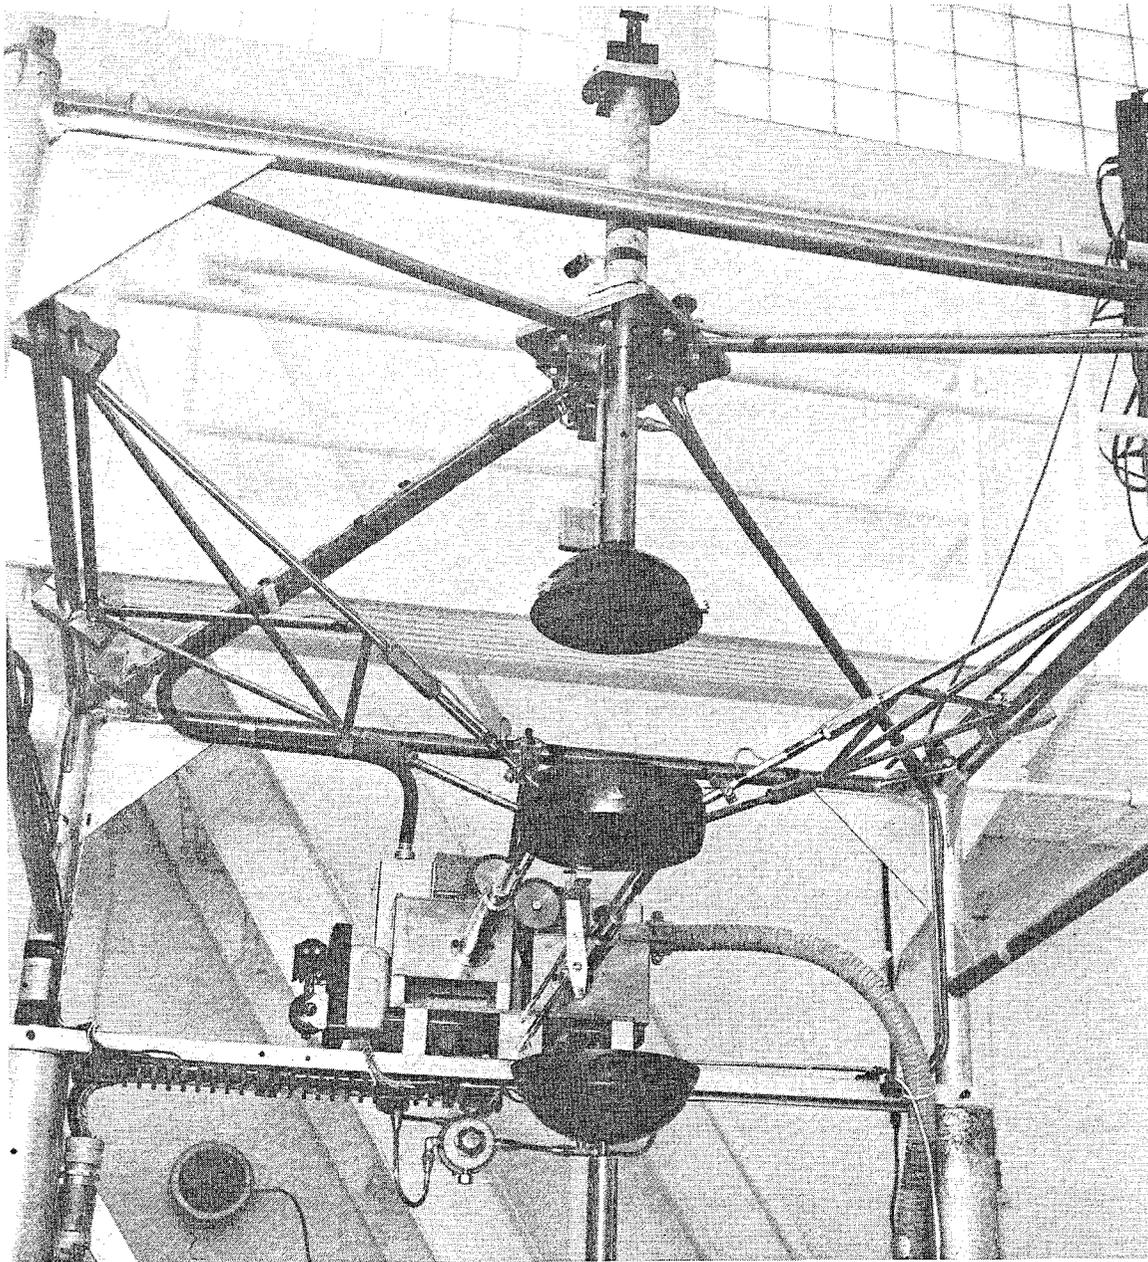
Fig. 14. The LASL Lady Godiva assembly (unreflected enriched-uranium sphere) in the
scrammed configuration.

These two excursions occurred in the Lady Godiva assembly, an unreflected metal reactor fabricated in three principal sections that, when assembled, formed a sphere. Figure 14 shows Godiva in the scrammed state. The central section was fixed in position by small tubular steel supports, while the upper and lower sections were retractable by means of pneumatic cylinders, thus providing two independent scram mechanisms. The critical mass was about 54 kg of uranium enriched to 93.7% ^{235}U. It was operated remotely from a distance of 1/4 mile.

The excursion yield was 5.6×10^{16} fissions, about six times the yield of the average burst. There was no radiation hazard, spreading of contamination, personnel radiation, or significant damage to the major uranium parts. One piece was slightly warped and required remachining. Several light steel supporting members were bent or broken (Fig. 15).

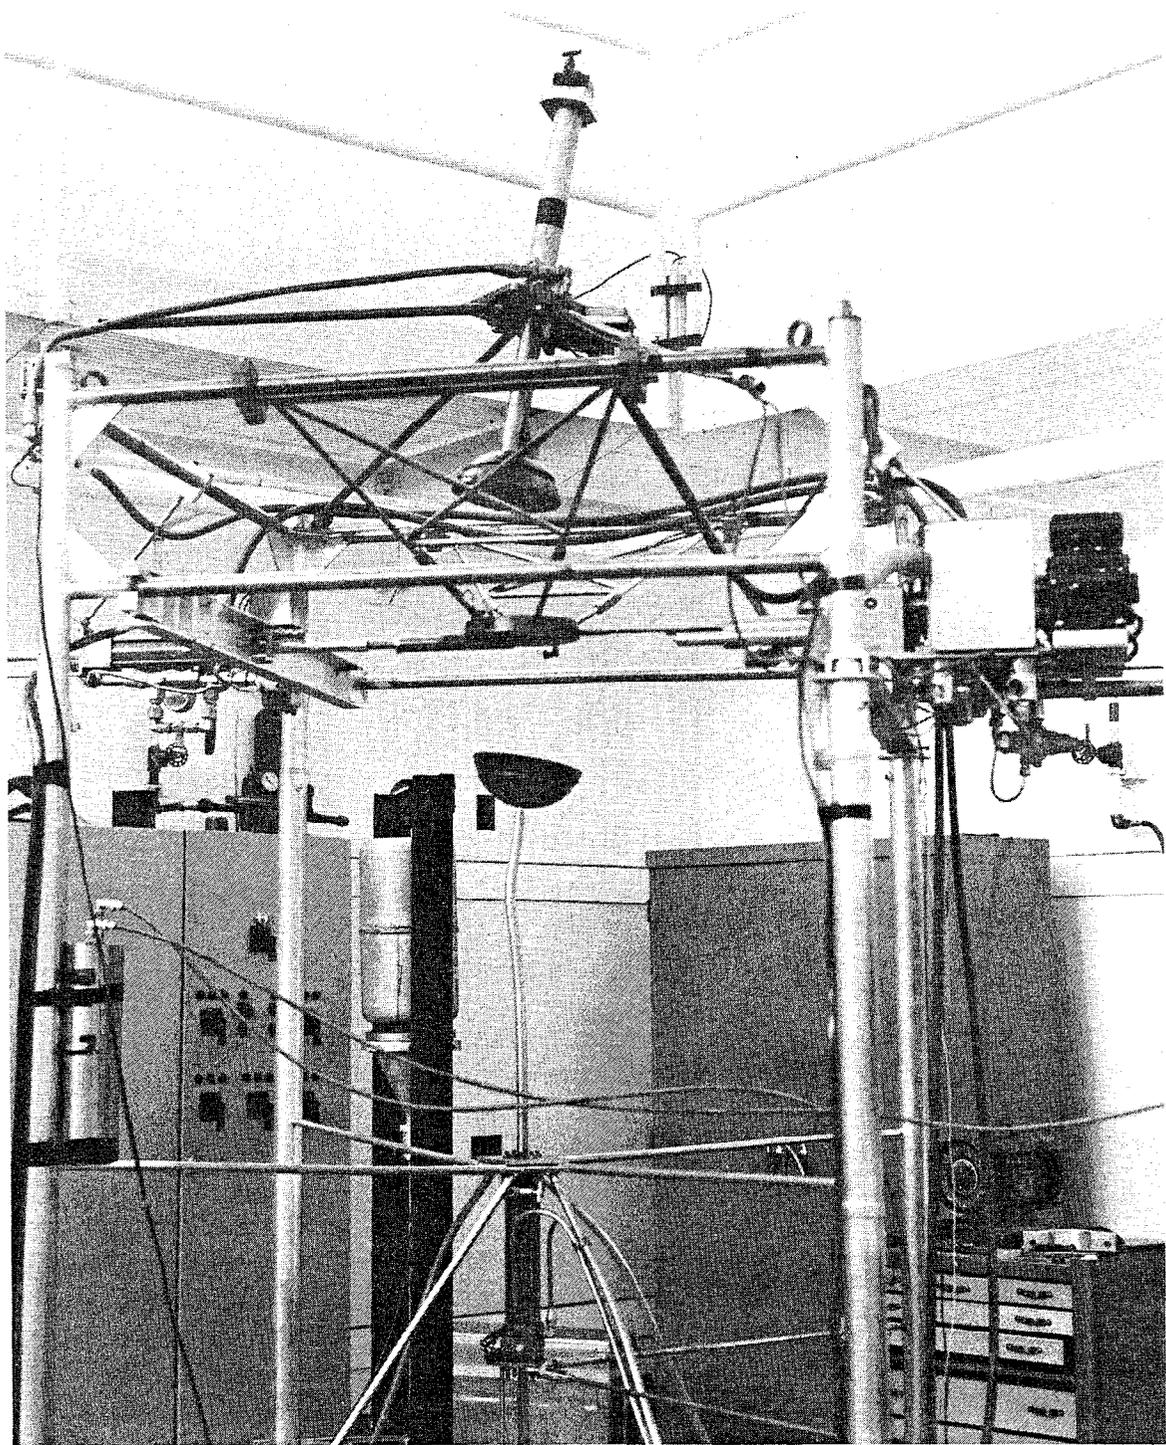
Fig. 15. Lady Godiva after the excursion of February 3, 1954 .

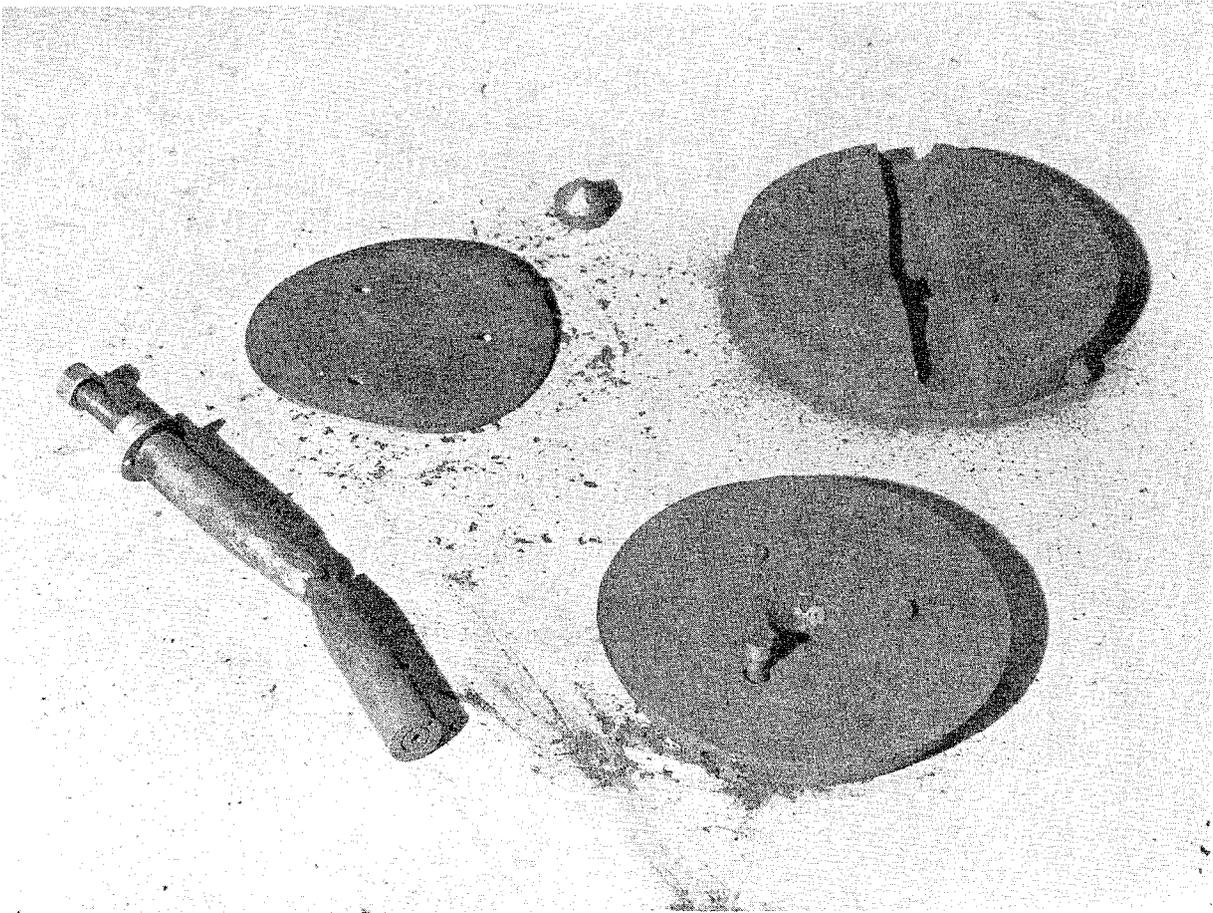
The burst yield was 1.2×10^{17} fissions, about 12 times the standard excursion. The uranium metal was severely oxidized, had warped, and apparently had been plastic near the center. The central burst rod was nearly ruptured and, at its center, must have been within 100°C of the uranium melting temperature. Figure 16 shows several of the pieces. External damage was limited to the supporting structure; radioactive contamination consisted of oxide scale; cleanup proceeded rapidly. Repair of Lady Godiva was not practical; therefore construction of Godiva-II,[30] specifically designed for burst operation, was accelerated. Despite the severity of the excursion, operating personnel received no significant radiation because of the large distance between the reactor and the control room.

The fission yield of 1.2×10^{17} in the second incident is equivalent to the energy contained in 1.7 lb of high explosive (HE), but the damage was much less than would have been caused by that quantity of HE. The above-mentioned code can predict the fraction of fission energy converted to kinetic energy; in this case, only about 1.4% of the energy, equivalent to 0.024 lb HE, was available as kinetic energy to do damage. The damage was consistent with this figure, and it is evident that most of the fission energy was deposited as heat.

Fig. 16. Burst rod and several sections of Lady Godiva showing oxidation and warpage
that accompanied the second accident.
