NUCLEAR CRITICALITY TECHNOLOGY

A Review of Criticality Accidents

William R. Stratton

March 1989

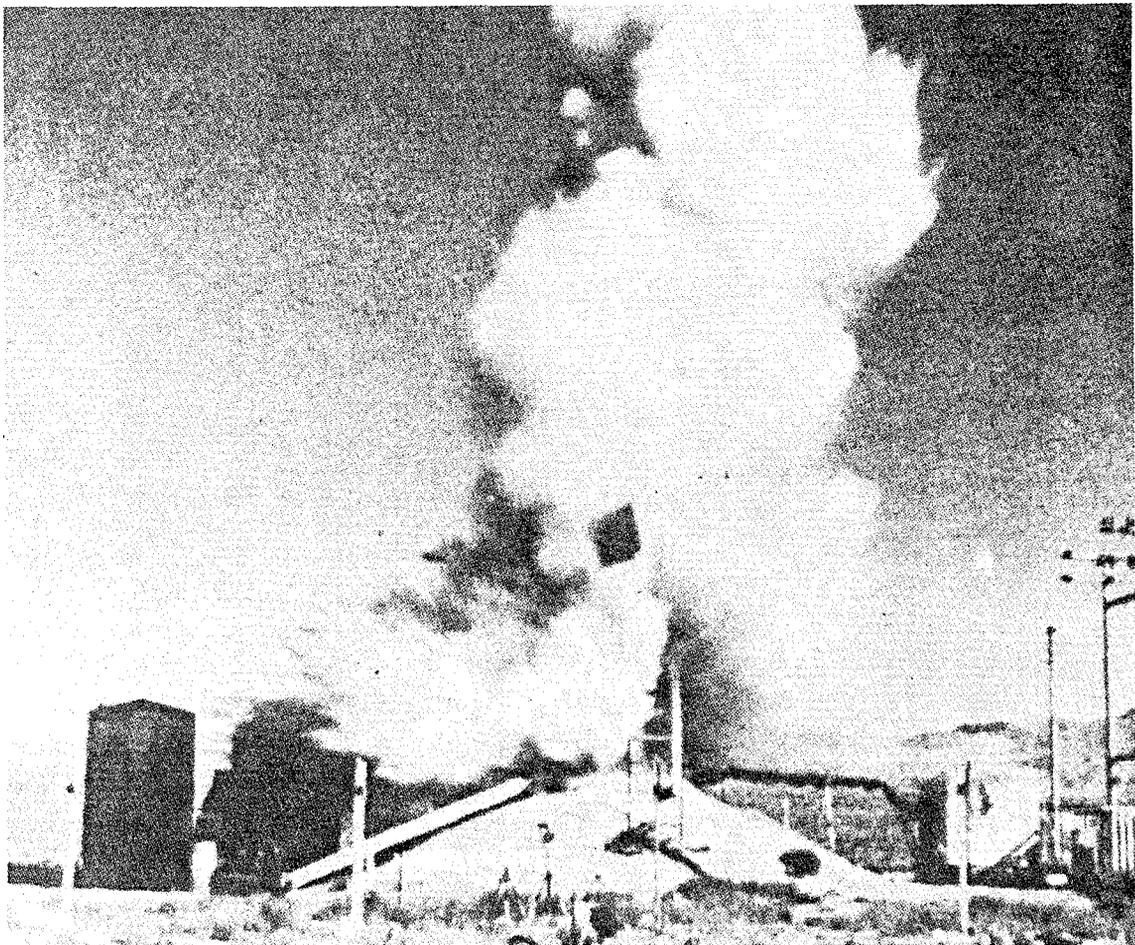
It had been estimated from earlier controlled prompt excursions that about 4% excess k would put the reactor on a period between 2.0 and 2.5 ms and that the resulting excursion would release about 80 MJ of fission energy. To perform this experiment a larger than usual fuel loading and a more effective central control rod were required.

The excursion and associated steam explosion, following rapid ejection of the control rod, completely disassembled the reactor core and ruptured the reactor tank (Fig. 17). Very extensive melting of the fuel plates occurred; some elements remained in the tank while small pieces were found up to 200 ft away.

Fig. 17. The destructive excursion in BORAX, July 22, 1954.

"An example of the force of the explosion was the carrying away of the control rod mechanism. This mechanism, which weighed 2,200 lb, sat on a base plate, about 8 ft above the top of the reactor tank. Except for the base plate, about 4 ft square, the top of the 10-ft shield tank was essentially unobstructed. The force of the explosion, plus the impingement of water and debris on the base plate, tore the plate loose from its coverage and, as revealed by high-speed movies, tossed the mechanism about 30 feet into the air."[41]

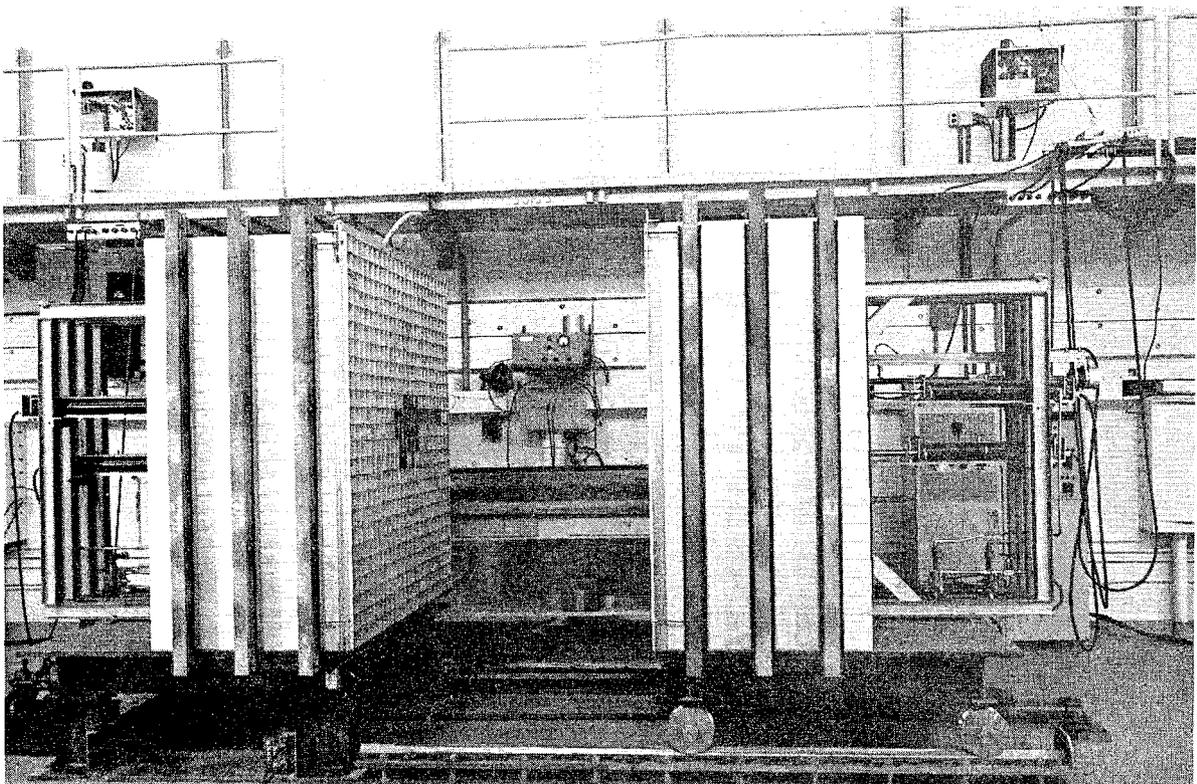
The stacking on July 3, 1956, consisted of 58 kg of enriched (93% ^{235}U) uranium in the form of 2- and 5-mil foils arranged between slabs of graphite with some beryllium reflector surrounding the core. The total mass of graphite was 1139 kg. At the time, some changes had been made in the reflector and graphite moderator, and criticality was being approached too rapidly for routine measurements. While the cart was moving at about 0.2 in./s, the system became prompt critical, a burst occurred, and the scram system retracted beryllium control rods (reducing reactivity) and reversed the motion of the cart. The burst yield was 3.2×10^{16} fissions.

Apparently this was a Dragon-type excursion in that the excess reactivity was added and subtracted mechanically. There was no damage and no contamination. Because it was remotely controlled from a distance of 1/4 mile, no one received any radiation.

Fig. 18. The LASL Honeycomb assembly machine. The movable section (right) is in the withdrawn position and the aluminum matrix is only partially loaded.

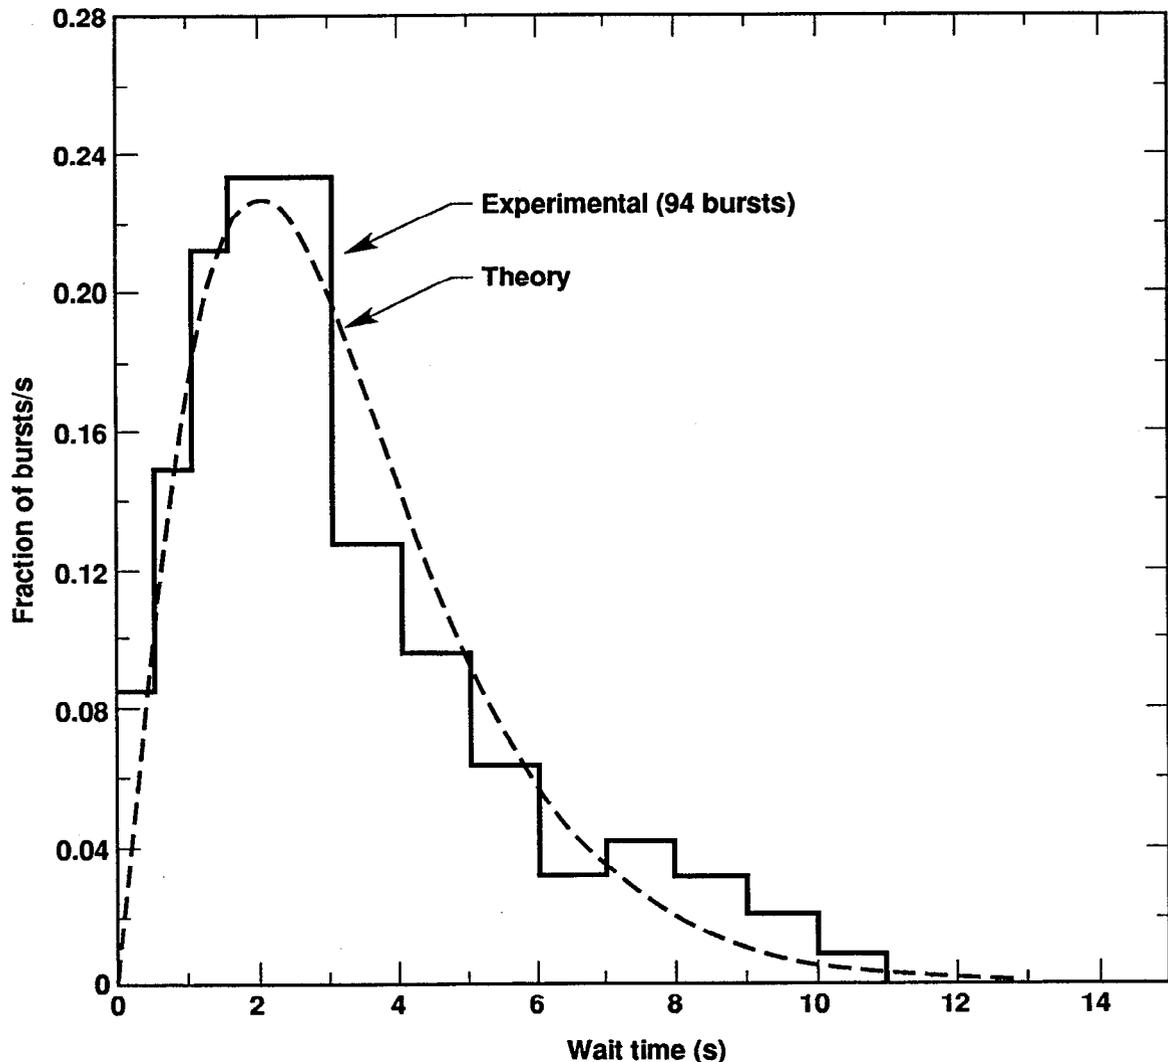
Post-accident analysis indicated that the extra reactivity resulted from a reactor configuration such that the burst rod passed through a reactivity maximum before seating. This condition had not been recognized; apparently on previous operations the burst rod had reached its seated position before the arrival of an initiating neutron. In the absence of a strong neutron source, wait times before an excursion occurs can be long. (See Fig. 21.)

Fig. 21. Distribution in burst wait times after quick (about 50 ms) insertion of 1.05 $ in Godiva II. Plotted is the fraction of bursts in each second vs wait time in seconds.
